## LATEST DRY BULKER AUDIT SERVICE IN CHINA PORT

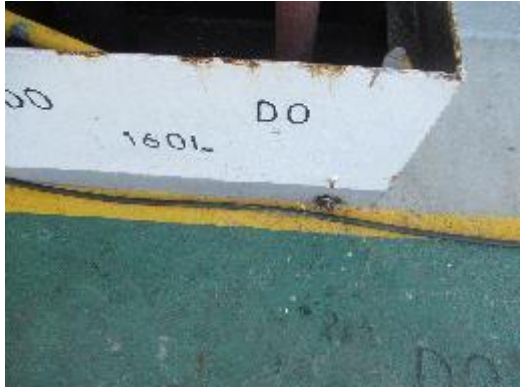
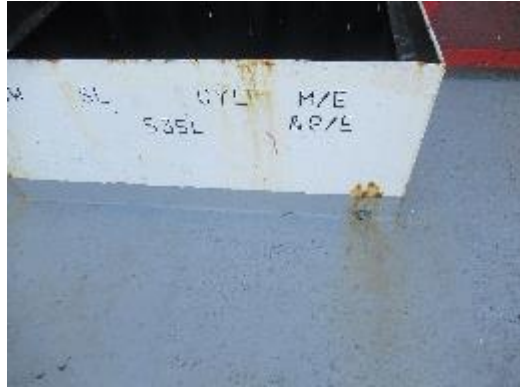
<p>Save all with plug</p>	<p>Chains for securing of plugs not in position.</p>

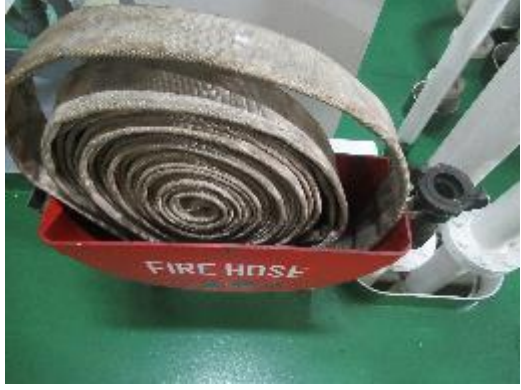
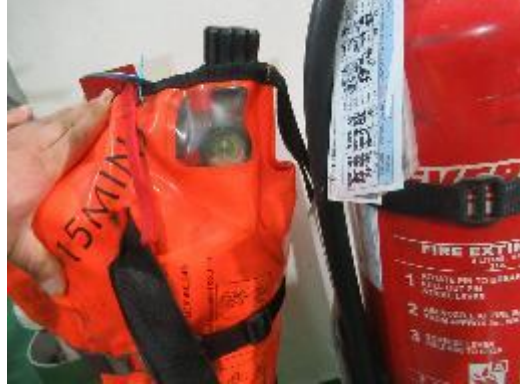
<p>Fire hose in engine room (15m in length)</p>	<p>Life saving apparatus in engine room</p>

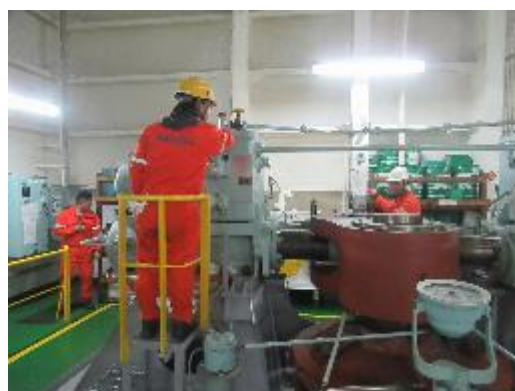
The min level of Hyd. Oil for s/g not marked in place

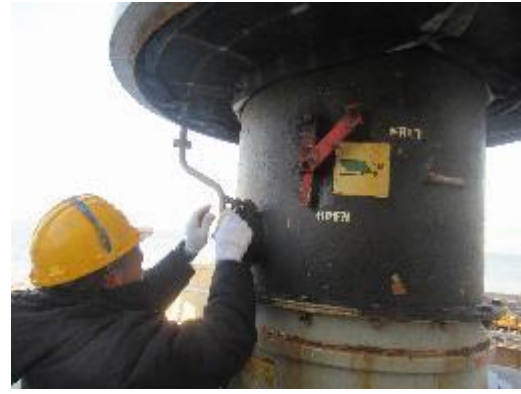
The hand levels were found rusty, advised to maintenance by chipping and scrapping

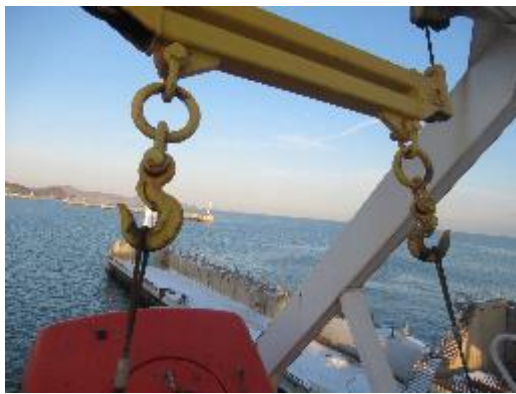
The latch of hook for boat falls were found clogged, advised to fair up and greased up

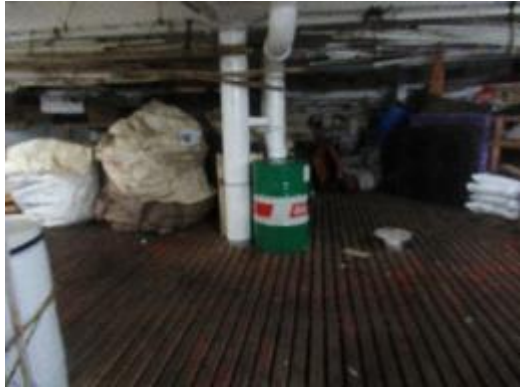
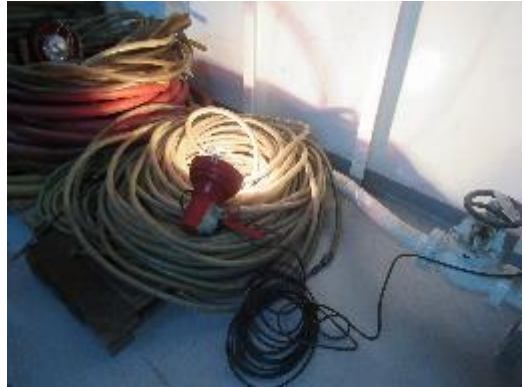
<p>Movable parts in Bosun need to secure by lashing materials</p>	<p>Movable parts in Bosun need to secure by lashing materials</p>

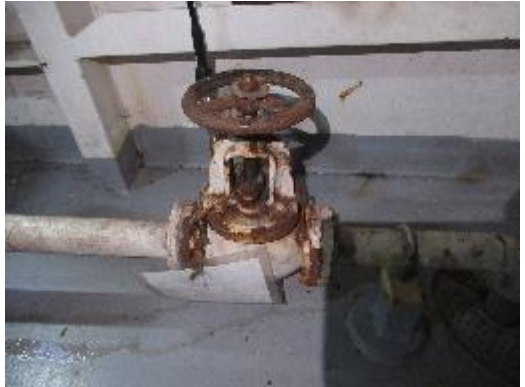
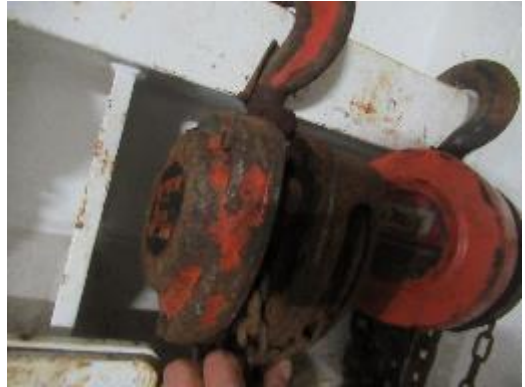
<p>Bilge valves for dewatering system in forward stores was found rust.</p>	<p>Few Chains blocks in forward stores need to maintain with SWL marking post.</p>

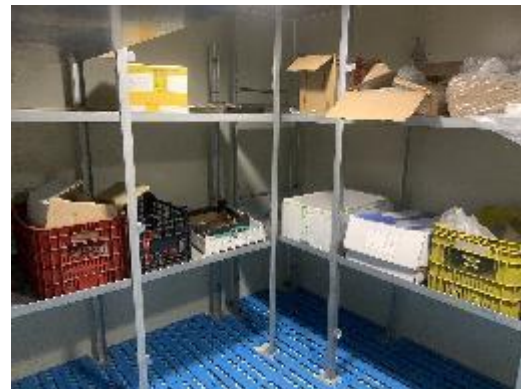
Provision stores, to be replenish at Dalian

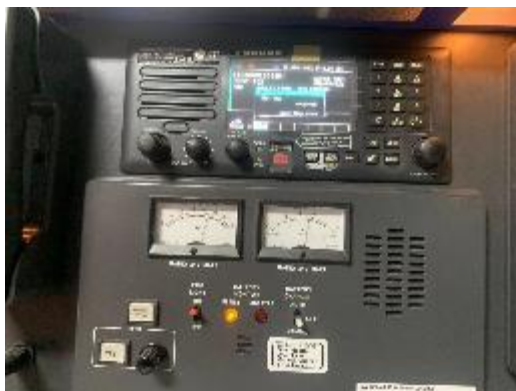
MF/HF DSC test, dropped down to 22V after
