PHOTOGRAPHS (DEFICIENCIES/OBSERVATIONS)

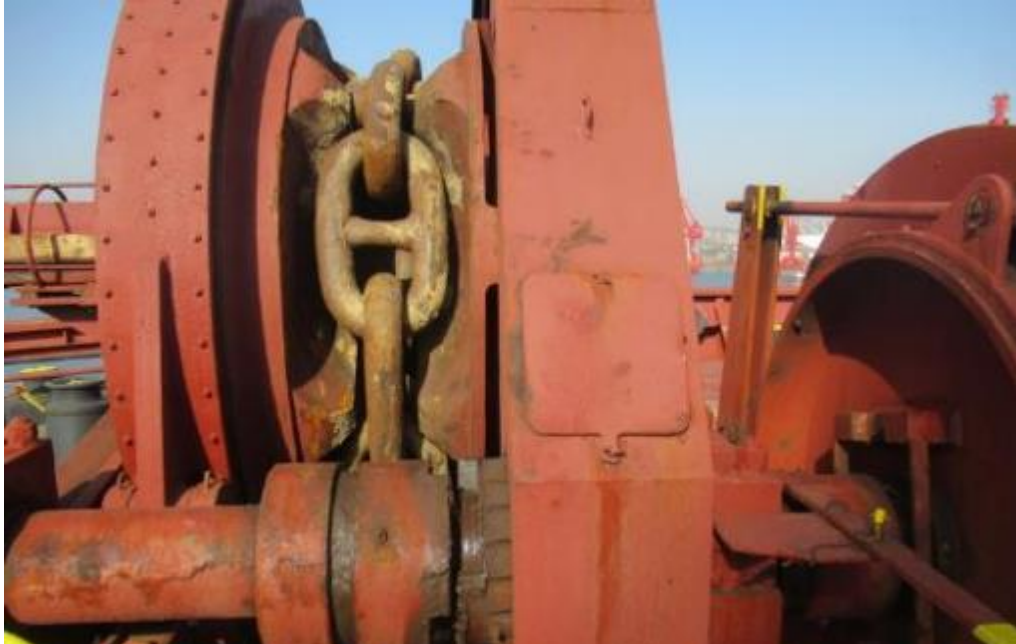
Picture 1: The grease windows for both anchor was found clogged.

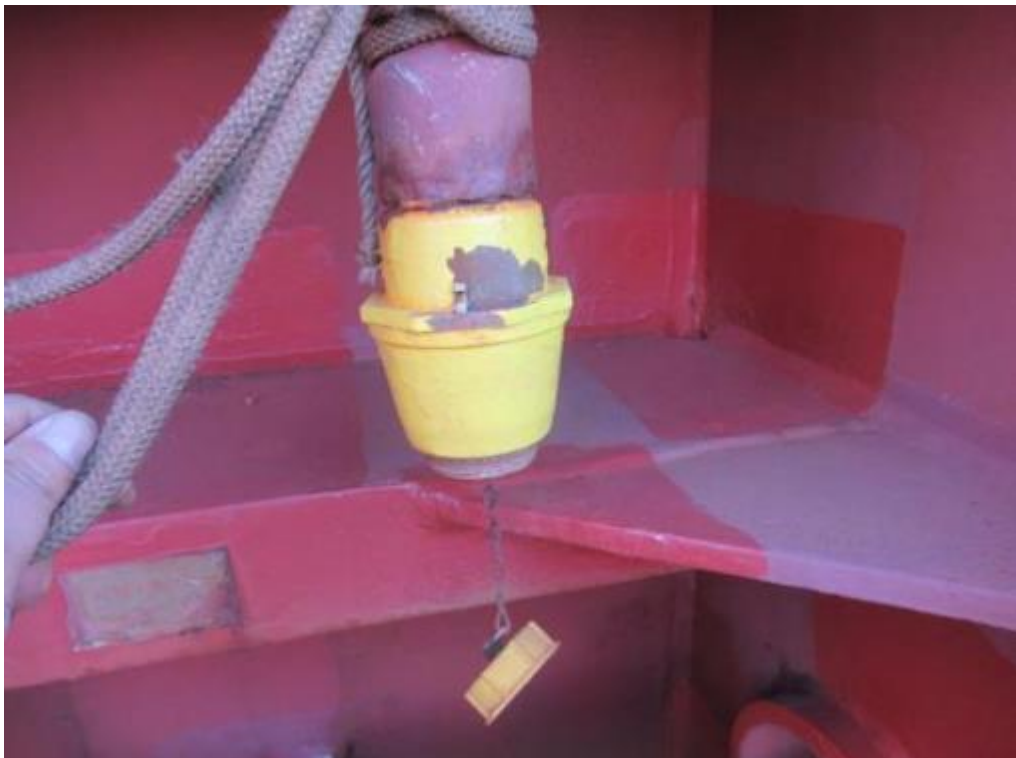
Picture 2: Some of the drainage balll acting as non return valves was found cloggd by foreigh materials.

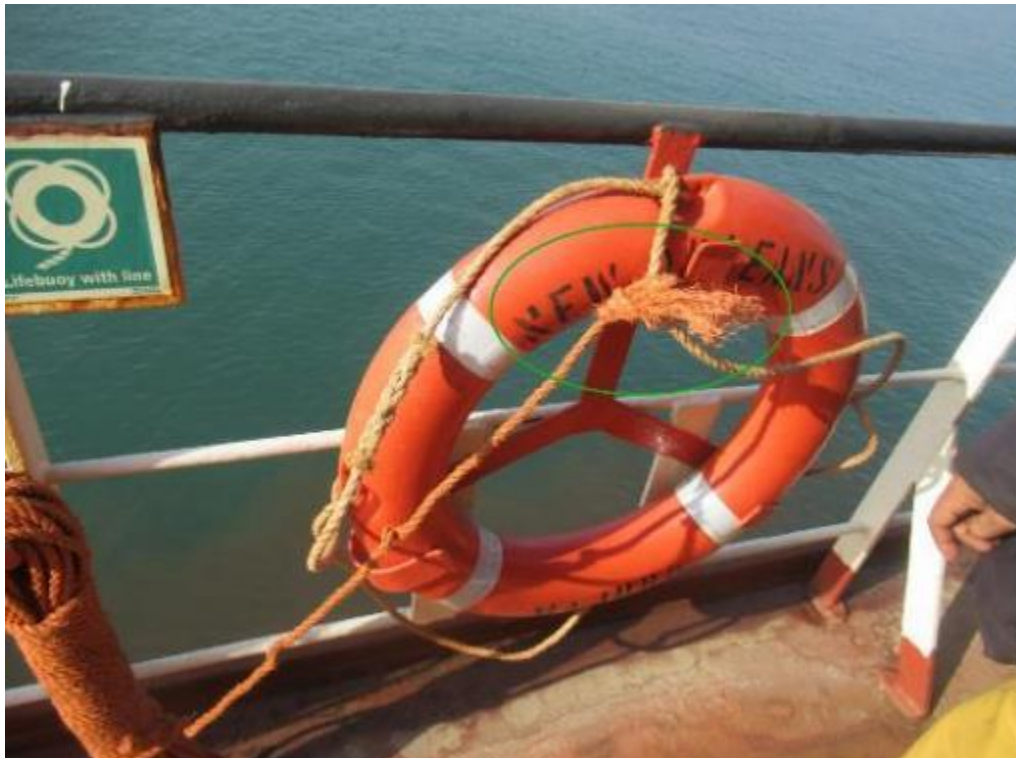
Picture 9: –Lots of wrongly connected between life buoy and life lines were observed.

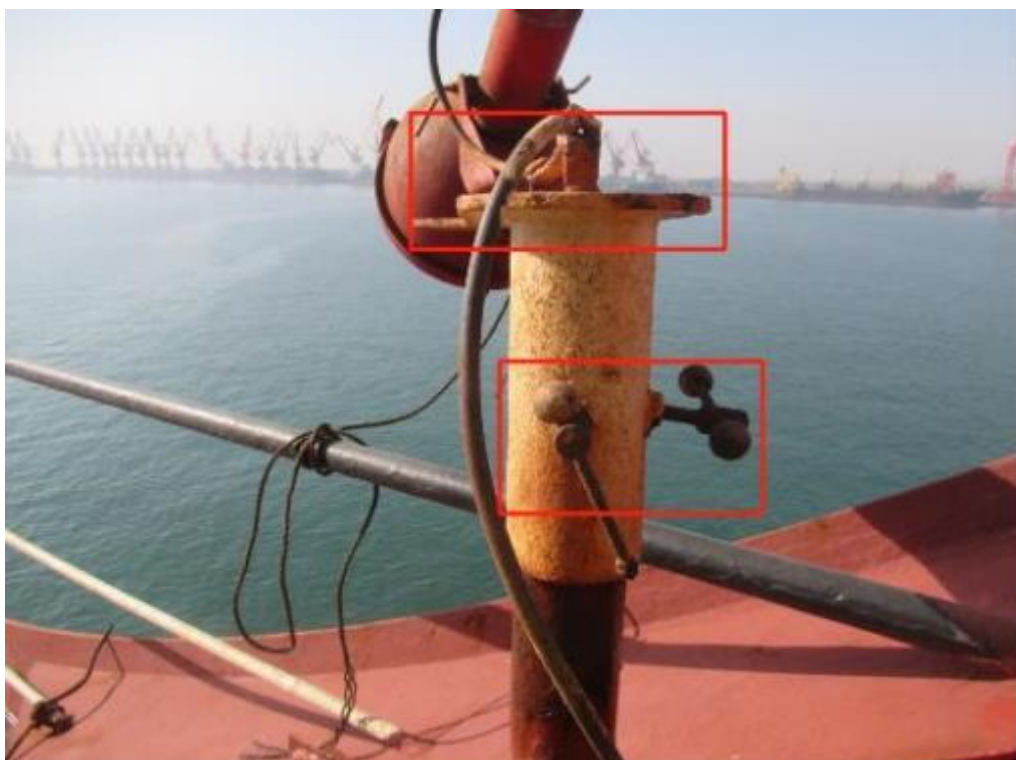
Picture 10: Lots of light pedestals for lighting system was found obstructed and clogged by paint and heavy rust. And tightening bolts also found wear down, advised to thoroughly check and repairing

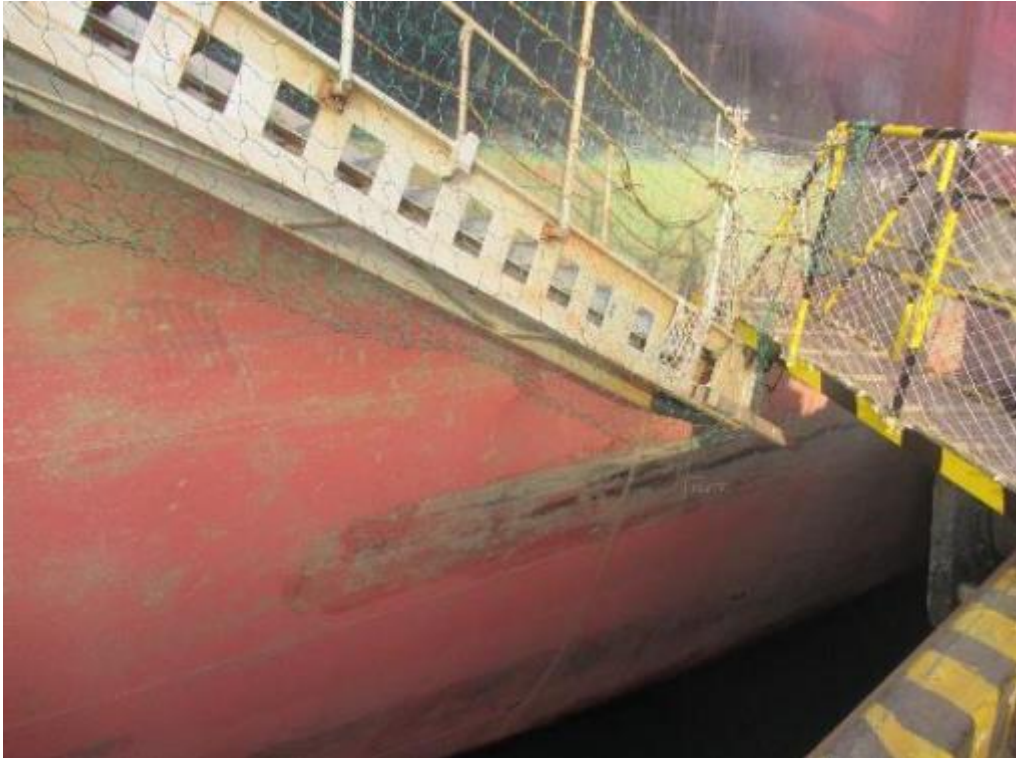
Picture 10 : the brow ladder supplied by shore side not protect with safety nets in compliance with AMSA recommendation

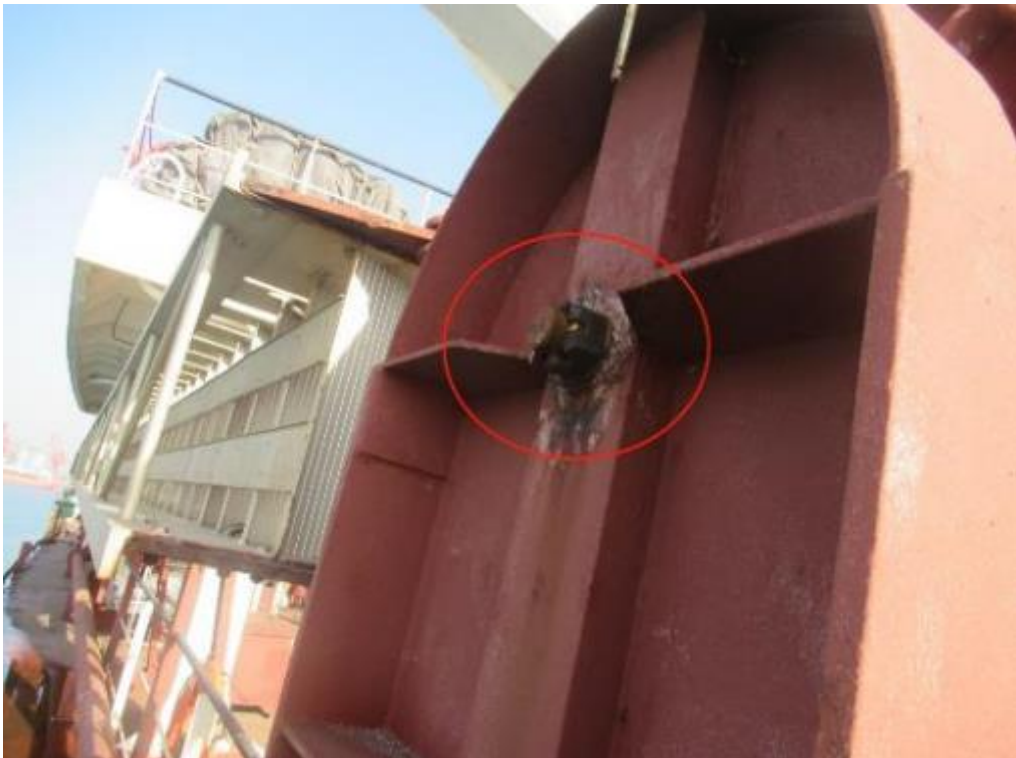
Picture 12: the turntables for accommodation on port side was found rust and obstructed, advised to fair up and grease up for freely operation.

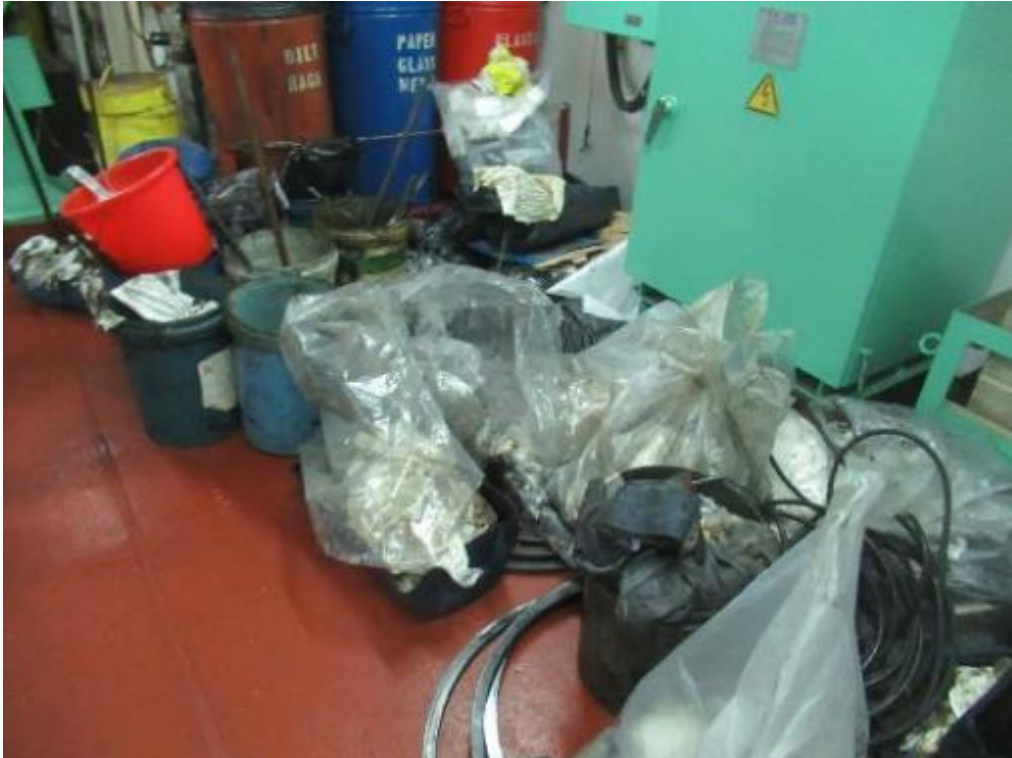
Picture 13: - Lots of oil rags were observed not improperly collected stored in suitable steel drum to prevent possible fire

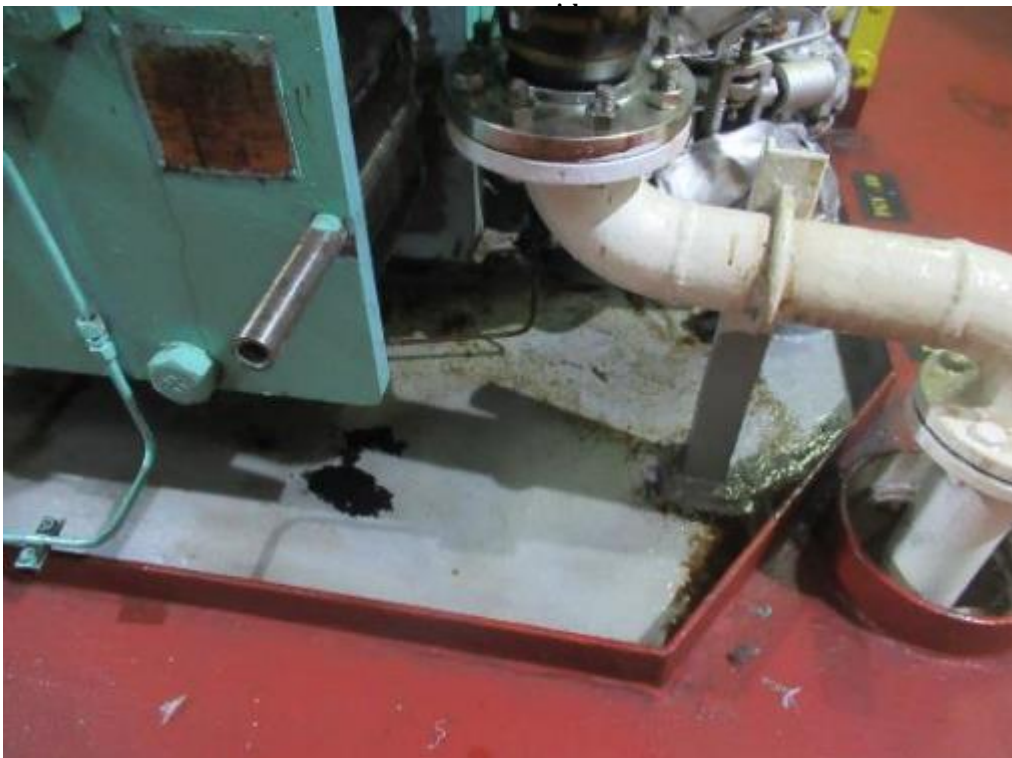
Picture 14-1: Oil leakage was observed under No.2/3 generator. Need to inspect and removal asap.

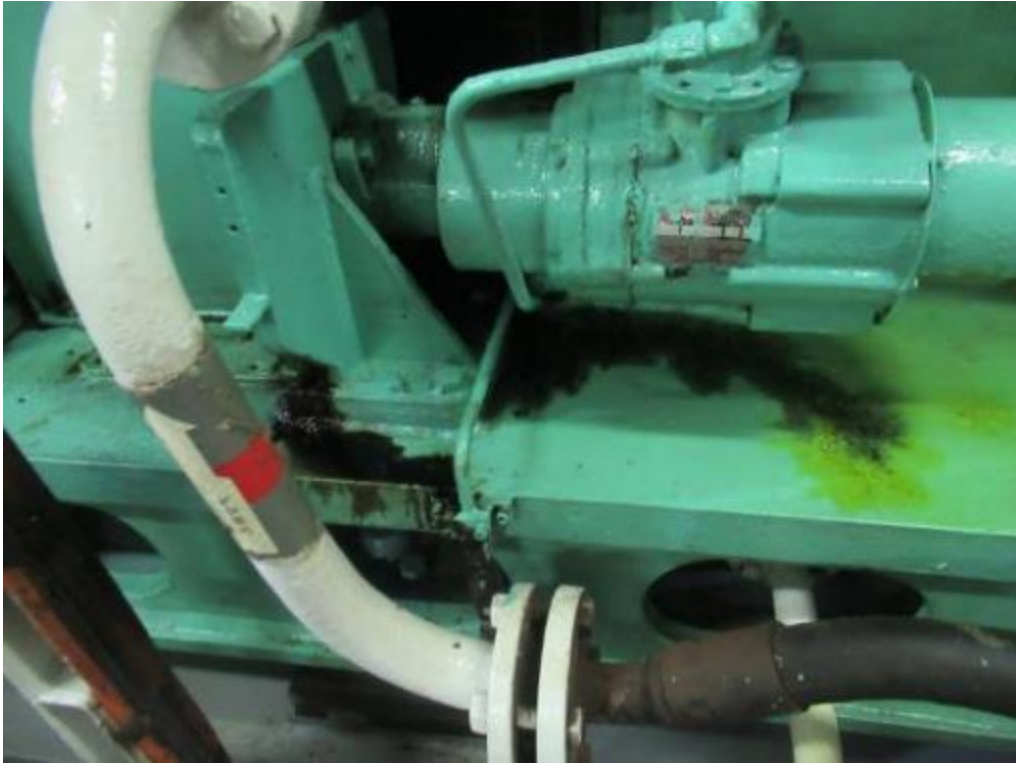
Picture 14-2: spilling oil was observed for both generator of No.2/3.

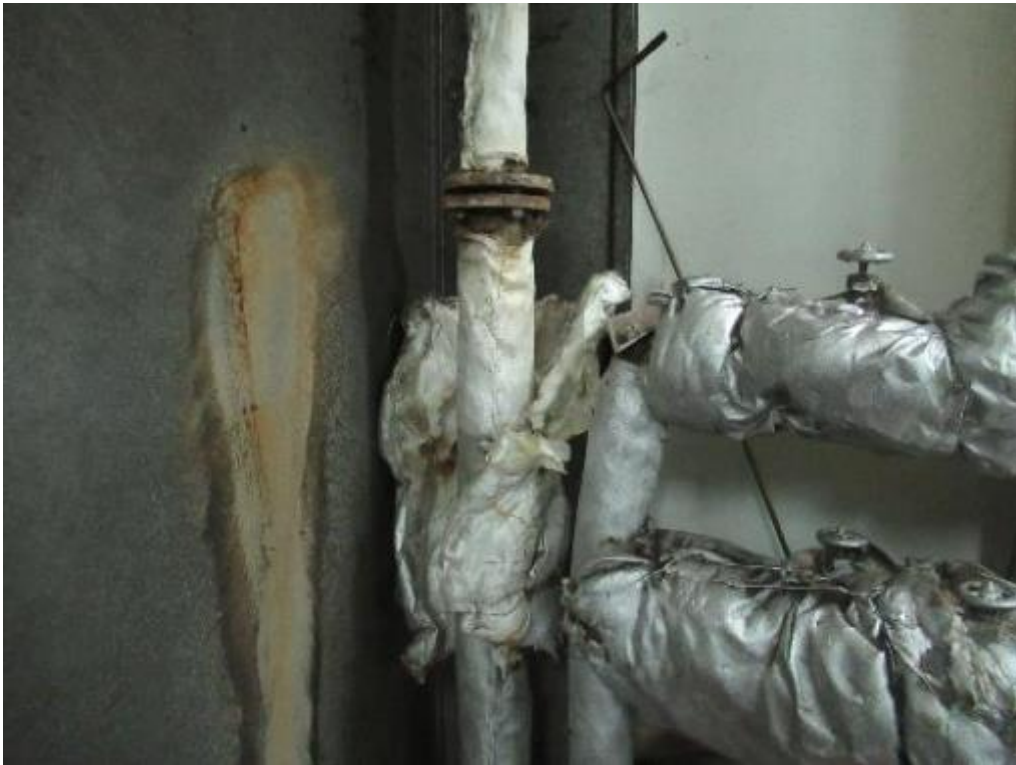
No.15 -1: Insulation laggings for hot surfaces and flanges in engine space were observed broken and oil taints.

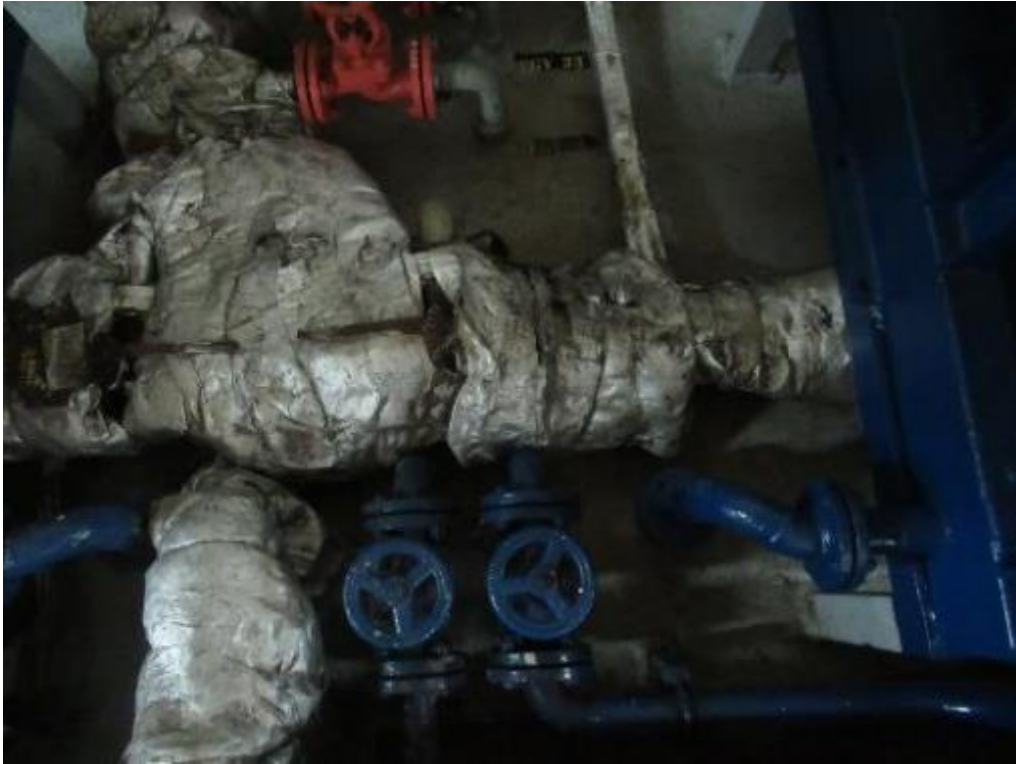
No.15-2 : oil taints and broken insulation laggings on the hot pipes in purifier were observed.

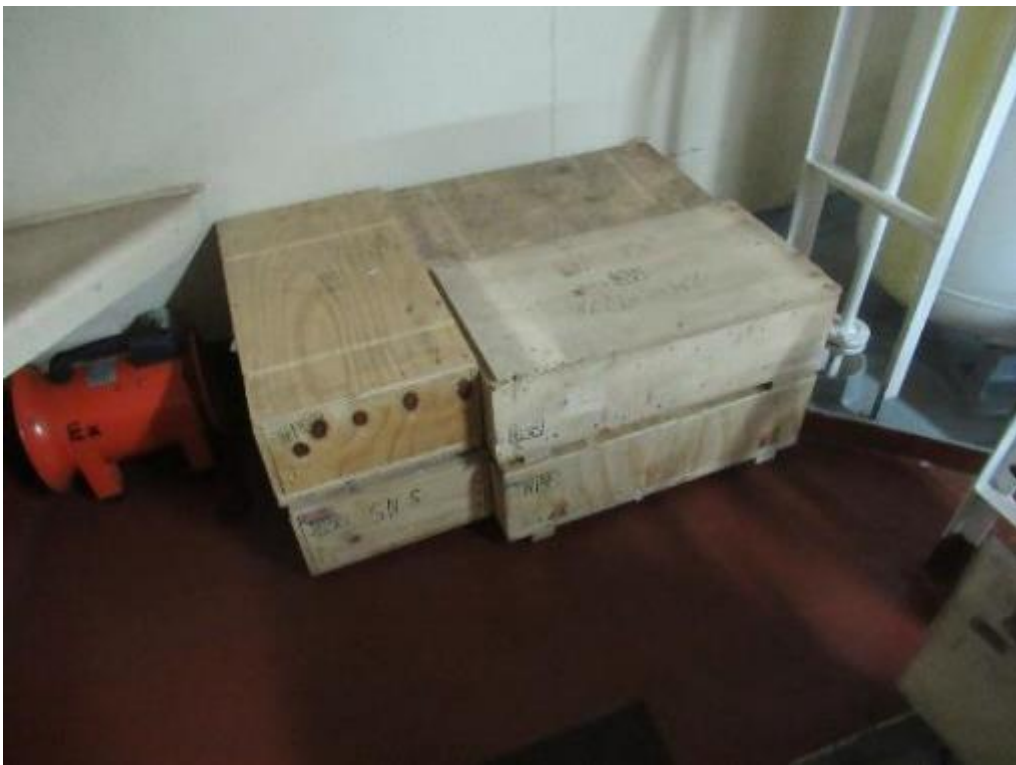
No.16 : Lots of newly supplied spare box in engine room were found not sea fastening for safe purpose.

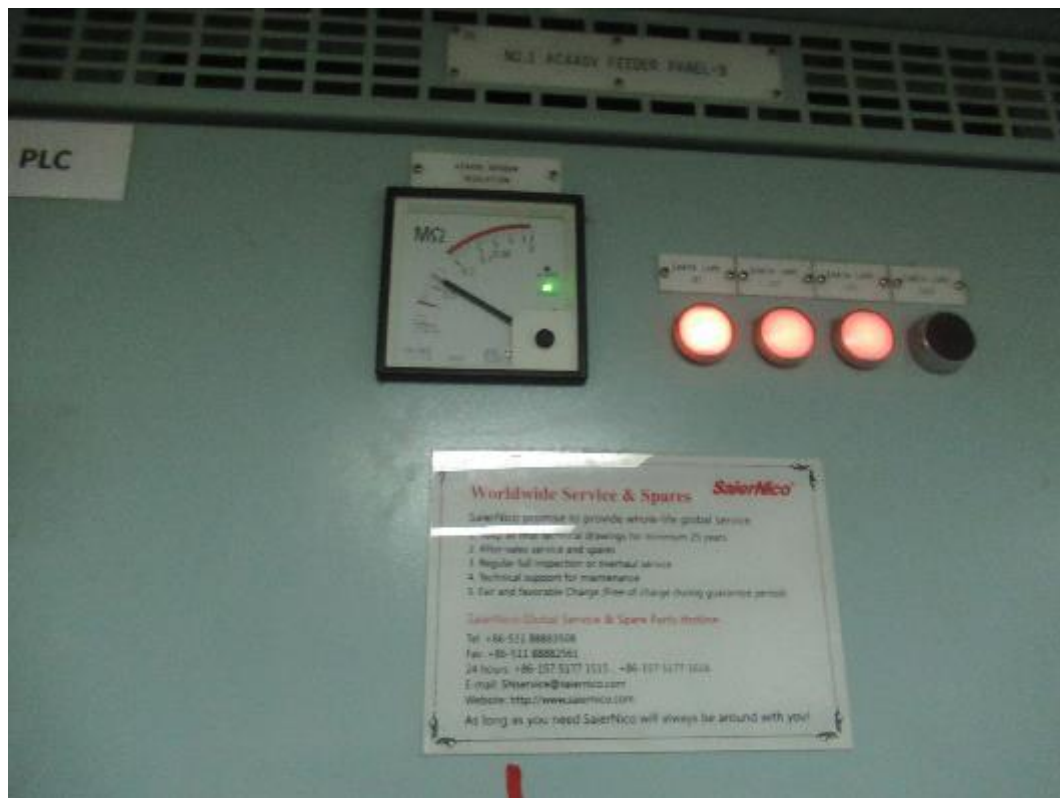
No.17 : the insulation resistance for 440V systems was found below 1 M during inspection.

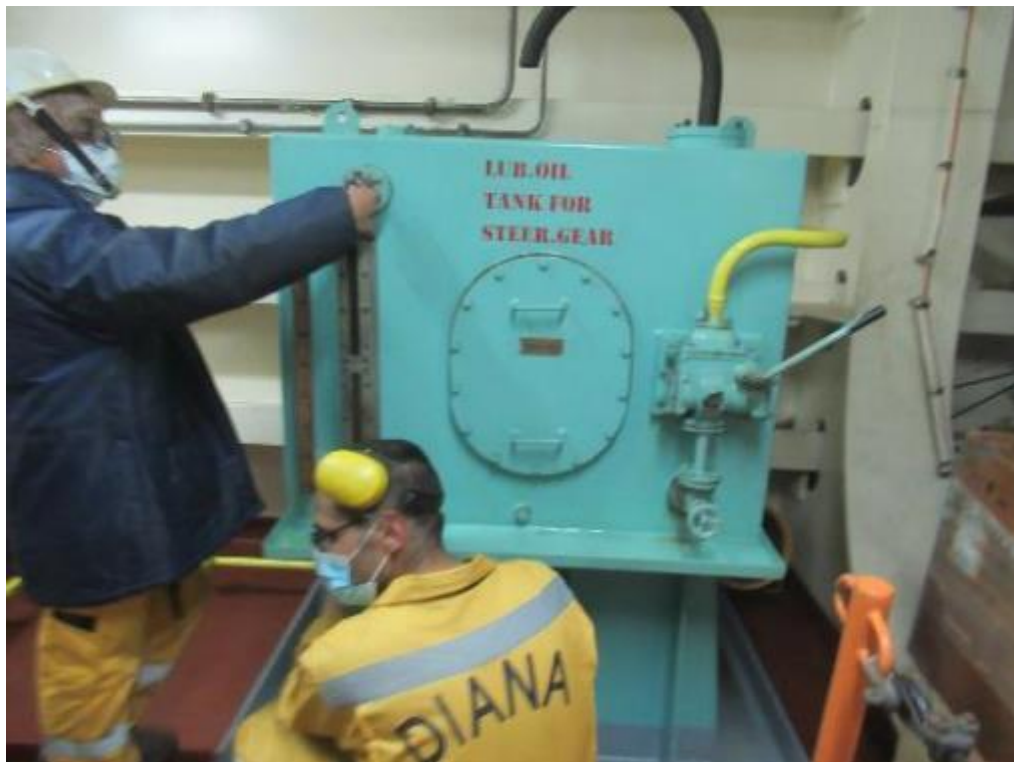
No.18 : the min level of oil gauge for LO steering gear oil tank not marked in place.
