PHOTOGRAPHS (DEFICIENCIES/OBSERVATIONS)

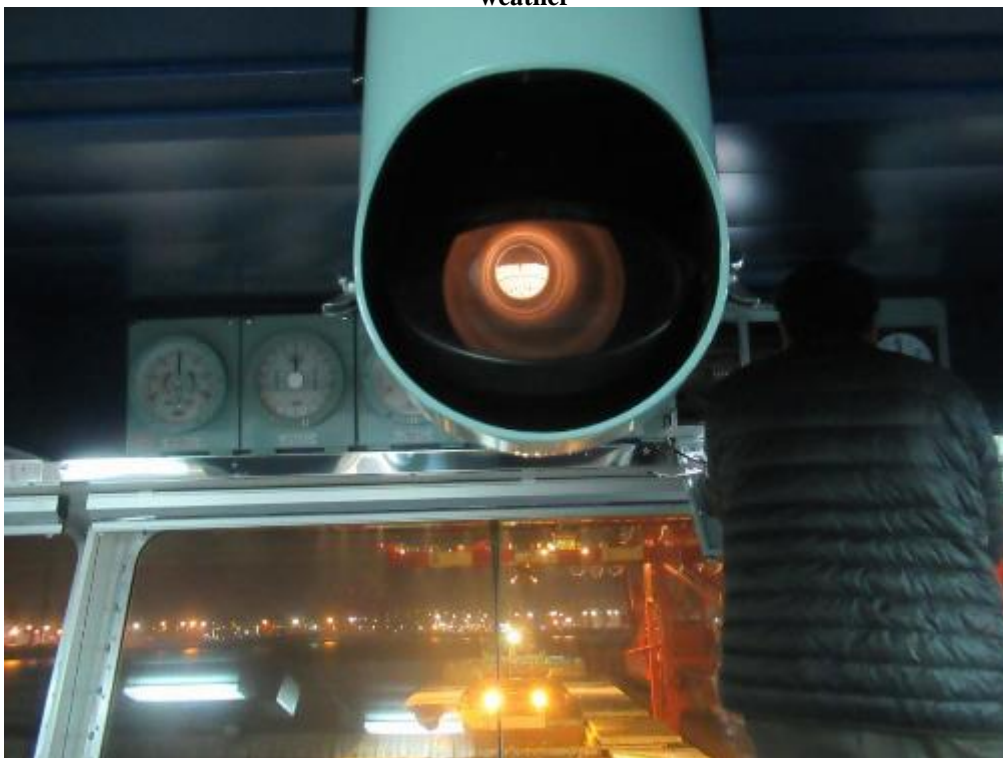
Picture 1: the deviation measurement for magnetic did not checked compare with Gyro Compass when bad weather

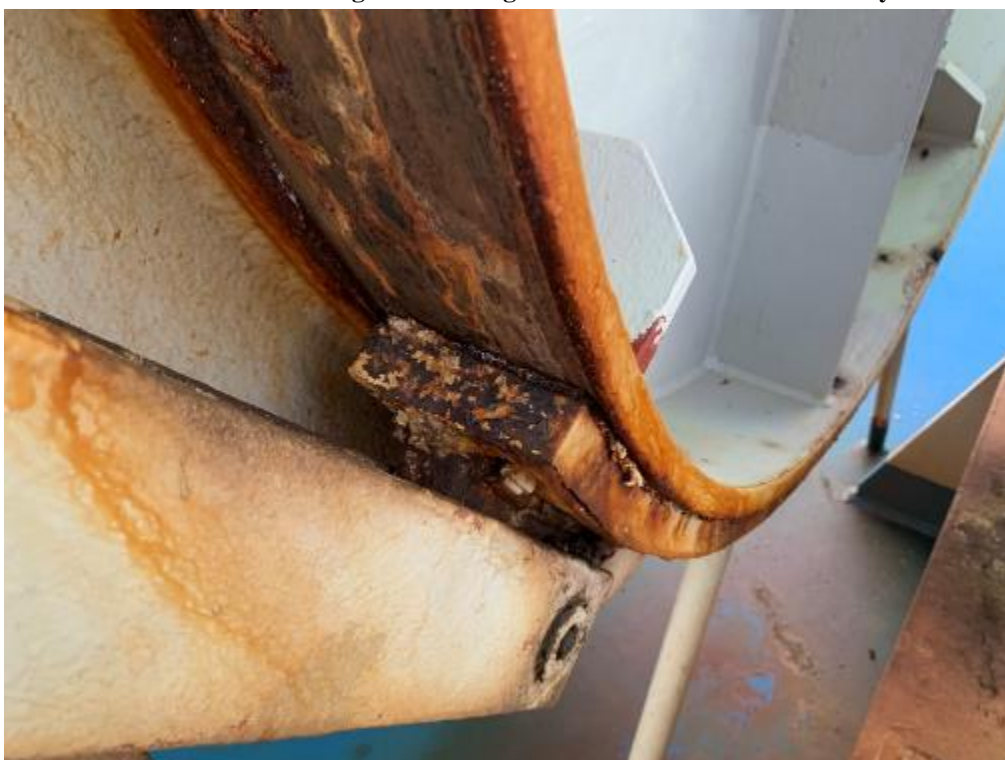
Picture 5: - 1.the mooring winch with grease windows was found heavily rust.

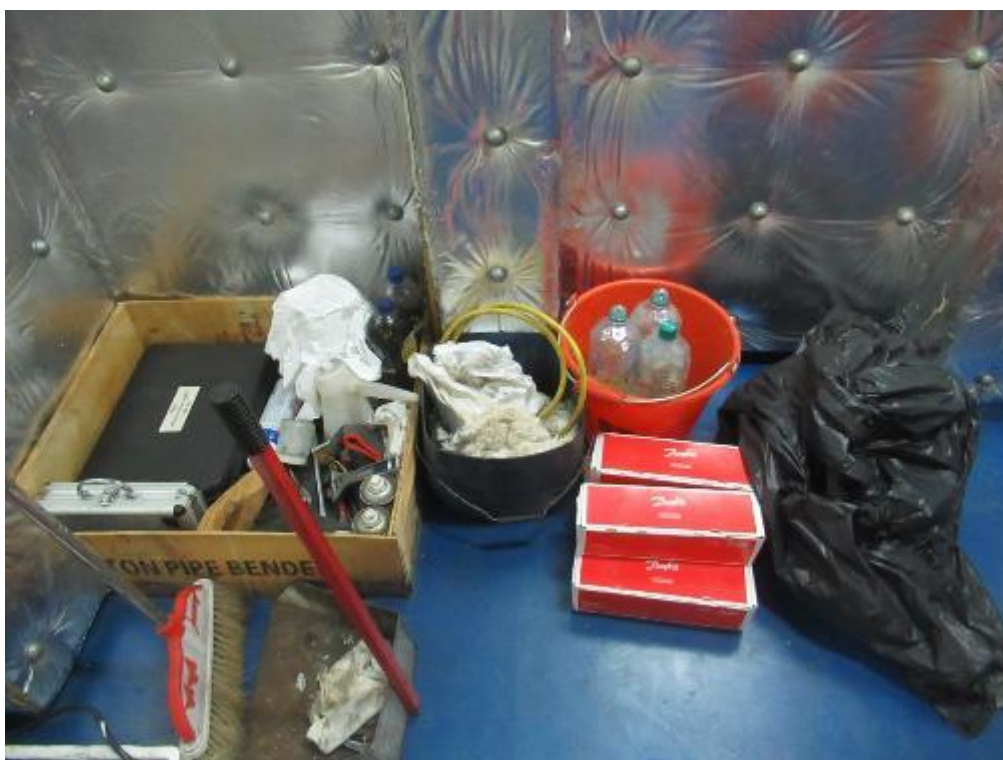
Picture 9-1: lots of oil rags in workshop was found incorrect storage.

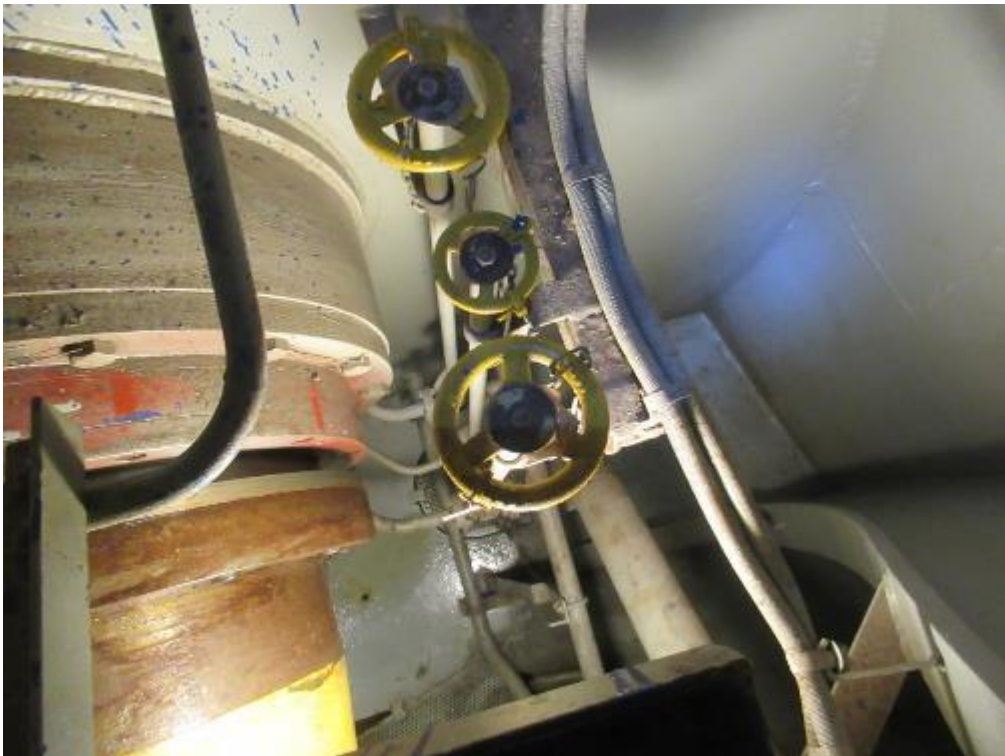
Picture 10: Continuous dropping oil from Level gauge of HSFOT was observed

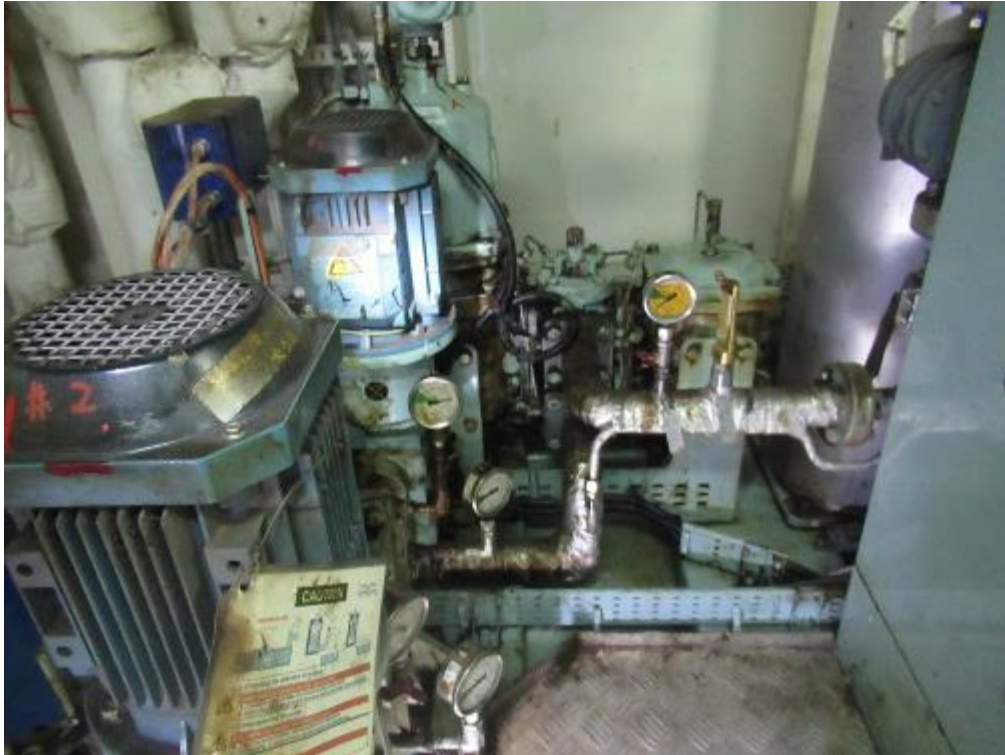
Picture 15-1: - The Purifier room was found dirty and oil leakage, black oil tant was observed on the heat insulation lagging .

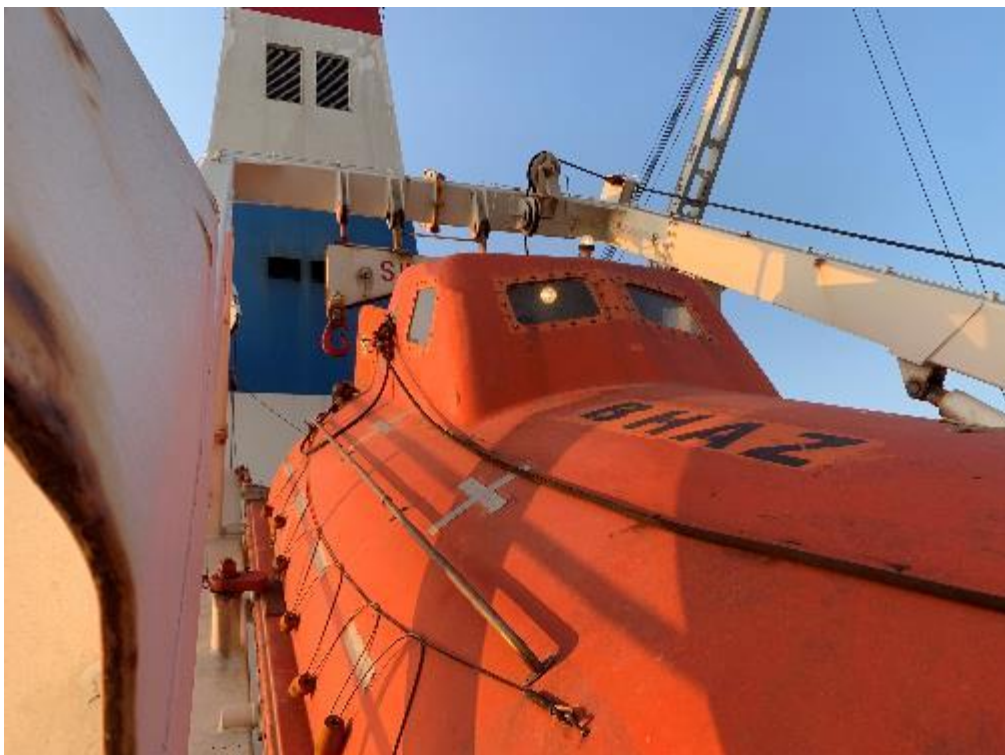
Picture 19-1: Rust on the hydraulic jack and davit for freefall lifeboat was observed, advised to maintenance and greased up as per PMS requirement
