3.1 STOWAGE

4.0 PRE-LOADING INSPECTION

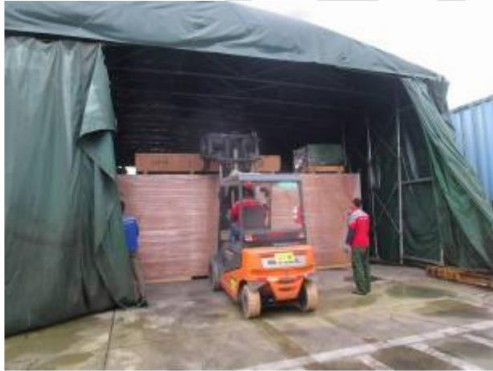
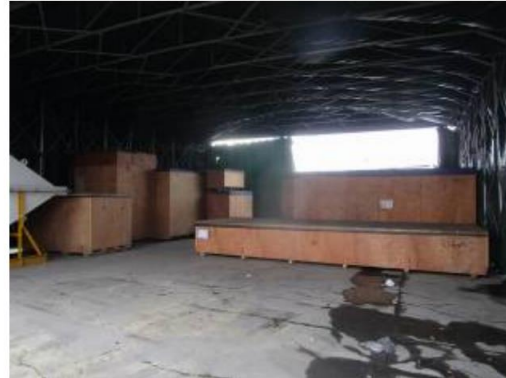
Wooden cases were stored at warehouse before loading.

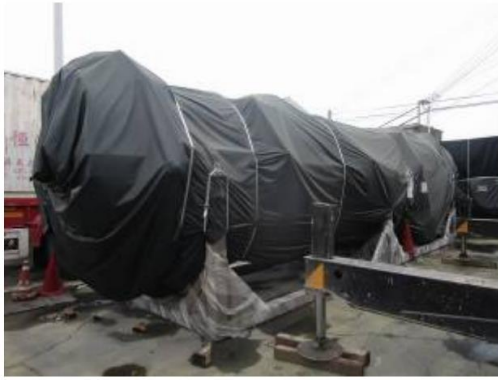
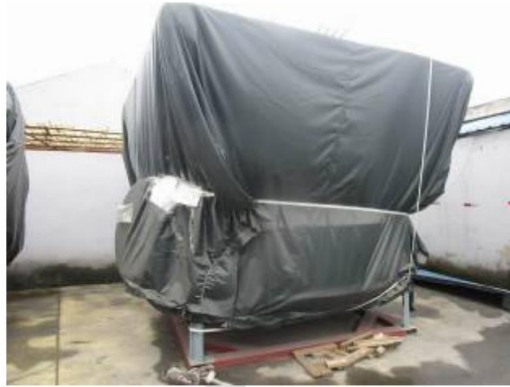
Cargo covered with tarpaulin

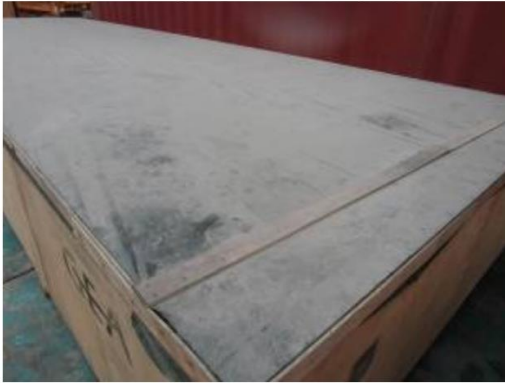
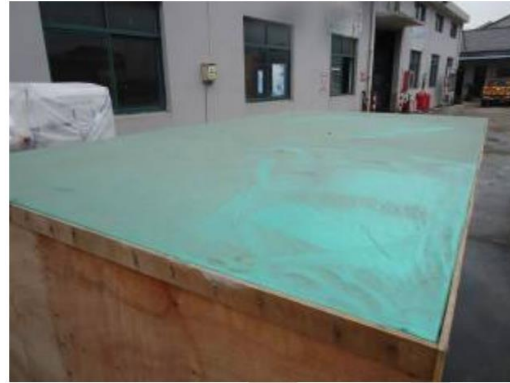
- All cargo was found without any damage.
- Dust and dirty stained on cargo package surface, affected all.

Dust stains on cargo surface before loading

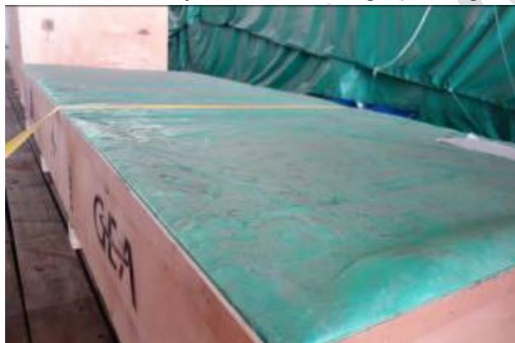
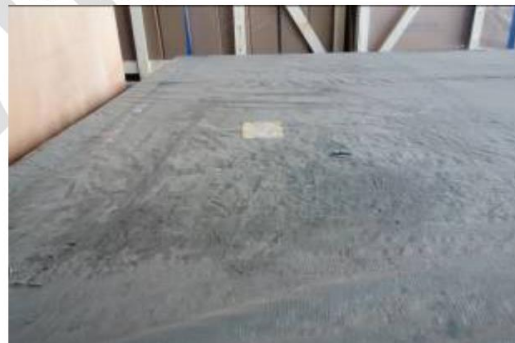
- All cargo was found without any damage.
- Dust and dirty stained on cargo package surface, affected all.
