3.1 STOWAGE

4.0 PRE-LOADING INSPECTION

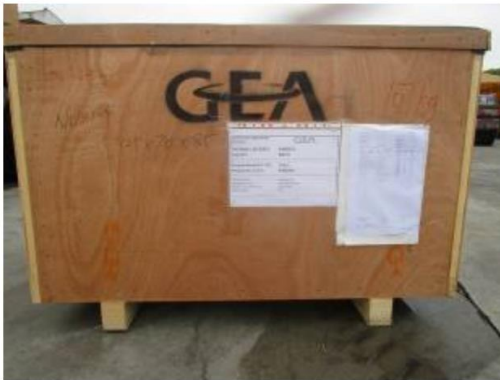
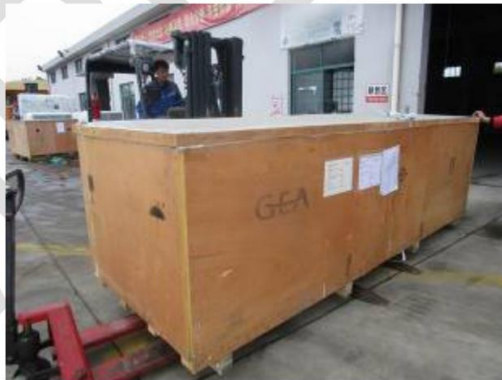
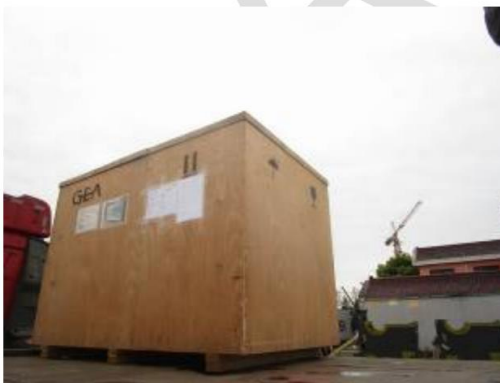
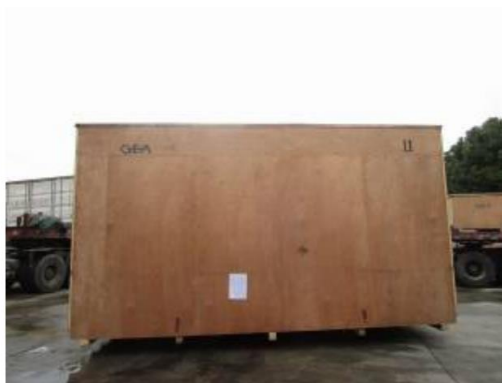
- Main shipping mark posted on surface.
- Auxiliary marks are in normal.

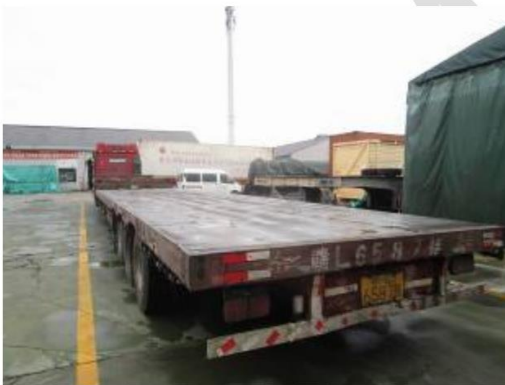
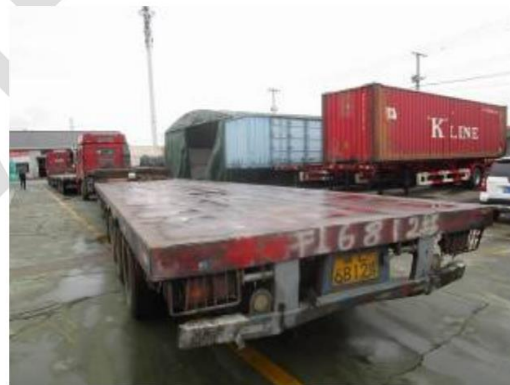
Our surveyor checked all trucks prior to loading and found they are clean and dry, all is in satisfaction.

Condition of trucks before loading

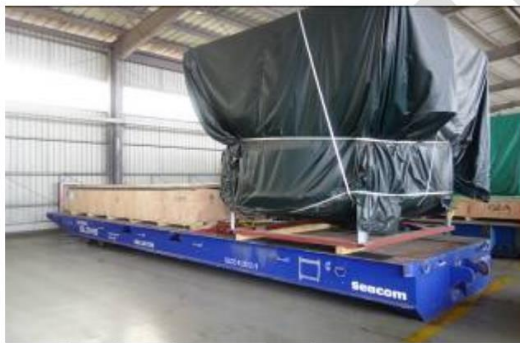
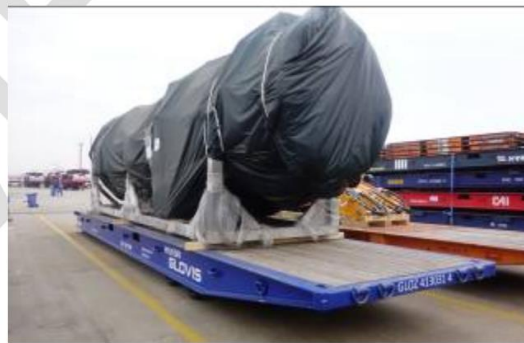
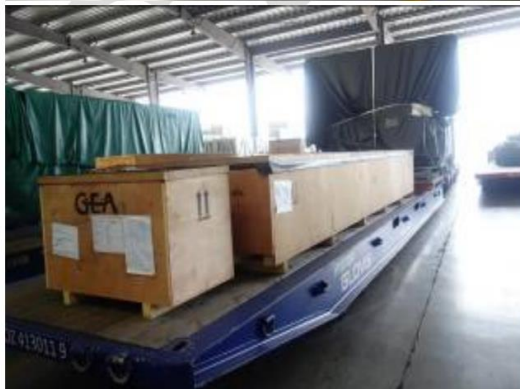
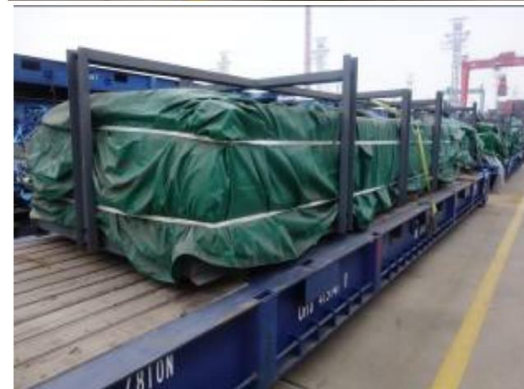
- After transferring operation, stacking condition of the twenty (20) packages in eight (8) mafi trailer. Detail as below:

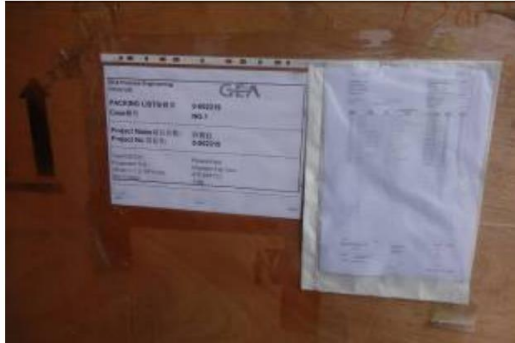
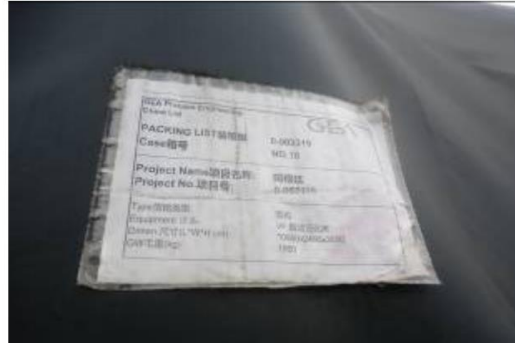
- Main shipping mark posted on surface.
- Auxiliary marks are in normal.

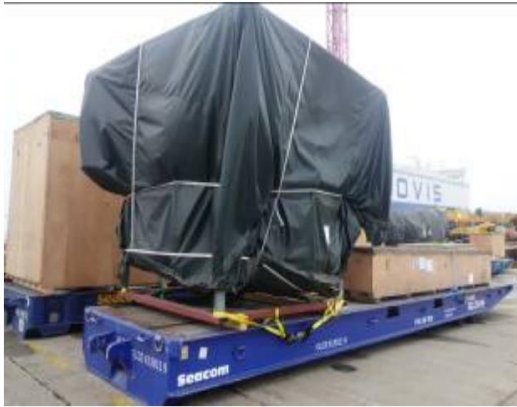
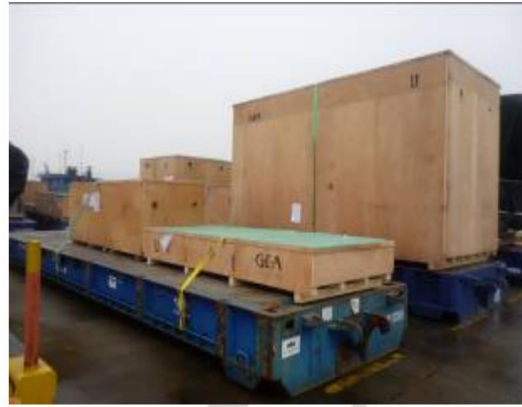
- All wooded cases were lashed with two (2) or three (3) lines lashing belts on Mafi trailer before loading.
- Chamber top cone, VF and CS frames were dunnage with wooden timber (100x10x10cm) at open yard and lashed with four (4) lashing belts before loading.

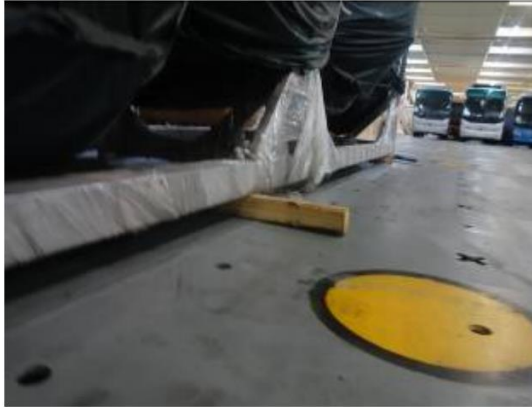
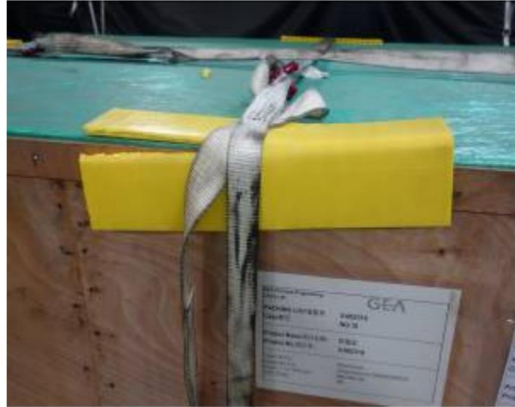
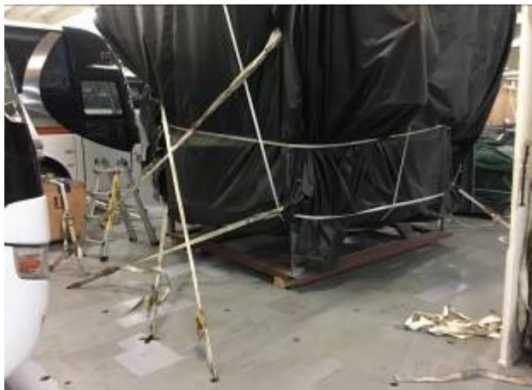
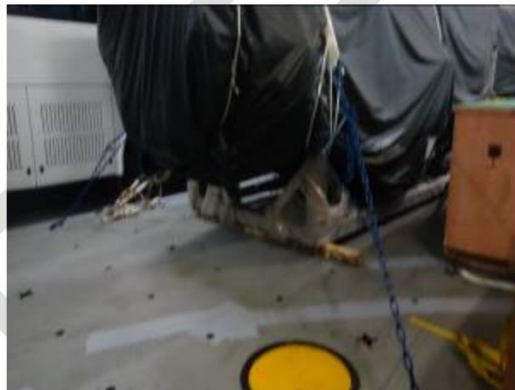
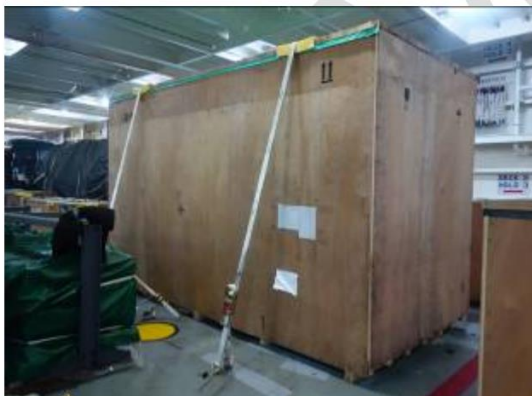
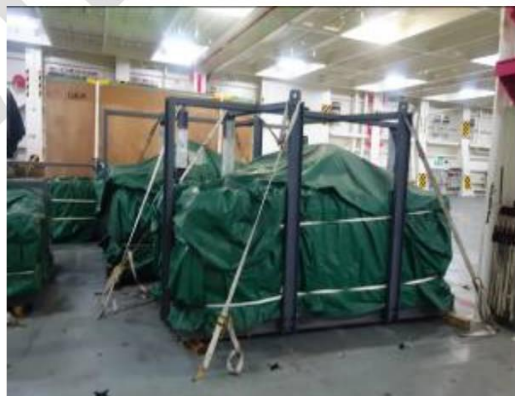
- Lashing material: Lashing belts (NBL5T), Chains (NBL 15T), Round sling (NBL 9T)
- Chamber top cone, VF and CS frames were dunnage with wooden timber (100x10x10cm).
- VF was secured on deck with total four (4) chains connect with eight (8) round sling (NBL 9T) at the lashing point.
- Static fluid bed was secured on deck by total eight (8) lashing belt (NBL5T).
- Frames were secured on deck by total eight (8) lashing belt (NBL5T).
- The wooden cases were secured on deck by lashing belts (NBL 5T), total two (2) or three (3) lines and protected with plastic plank
