## LATEST DRY BULKER AUDIT SERVICE IN CHINA PORT

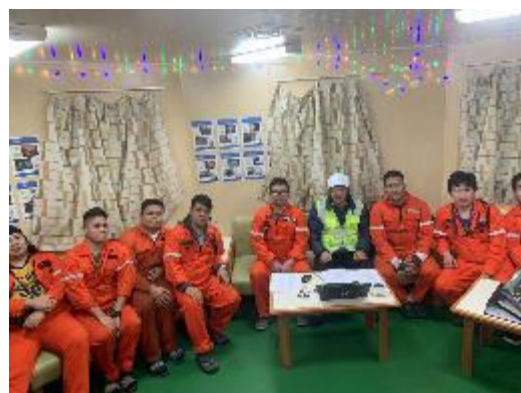
Carried out Opening meeting

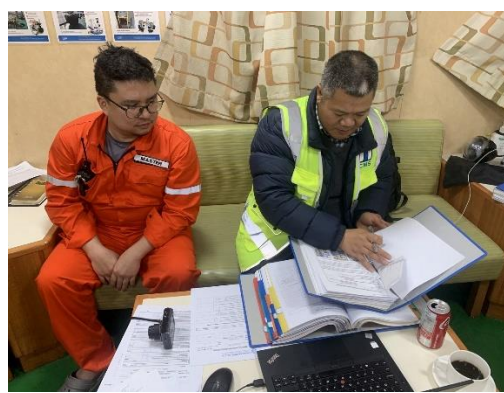
Audit job in progressing

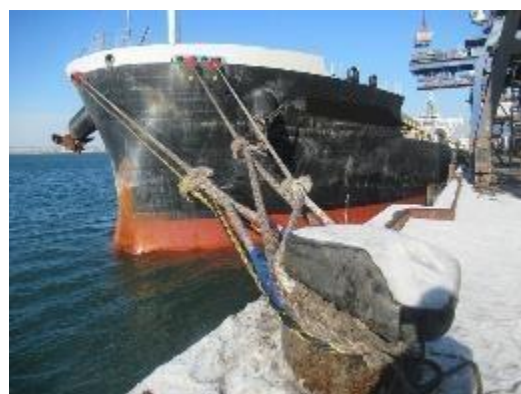
Forward view

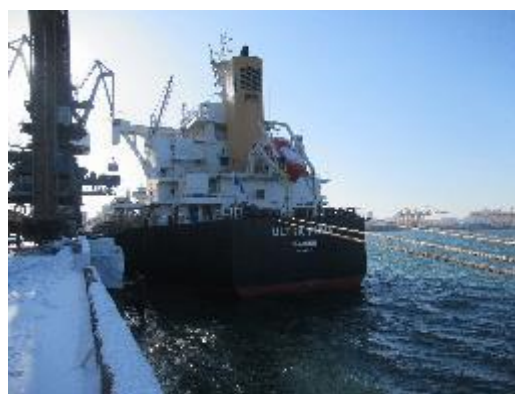
After view

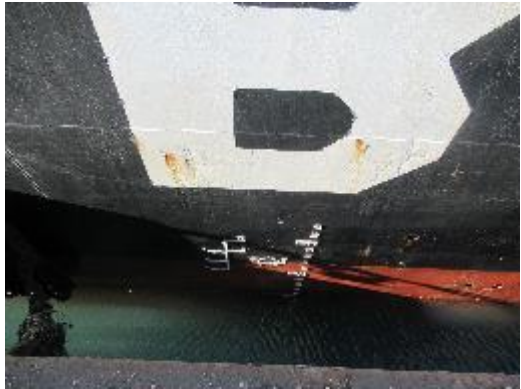
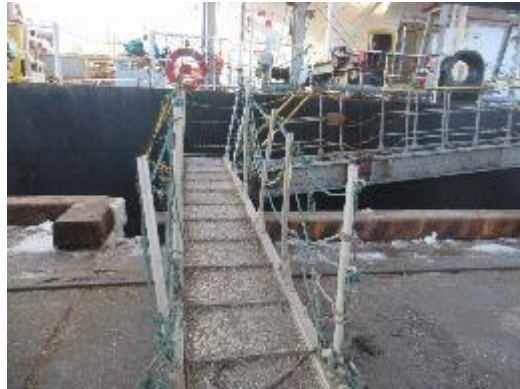
<p>Mid ship with draft markings</p>	<p>Accommodation ladder access</p>

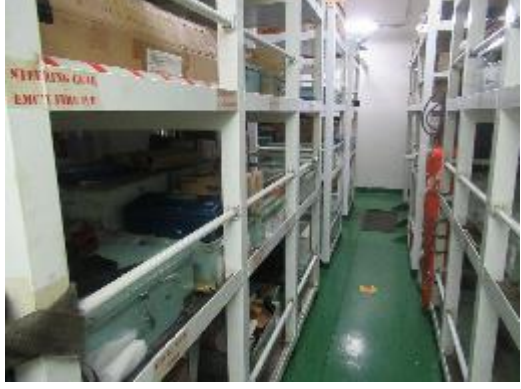
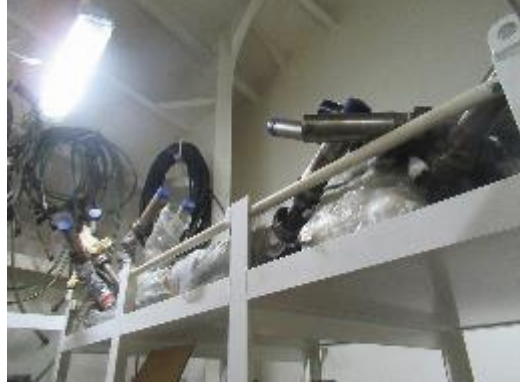
<p>Inventory of spare parts in storage</p>	<p>Inventory of spare parts for critical equipment</p>

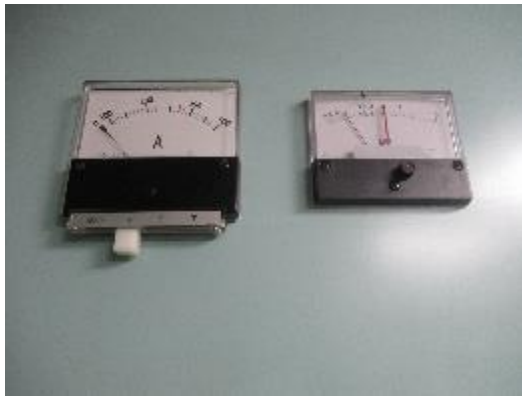
Insulation resistance of 220V

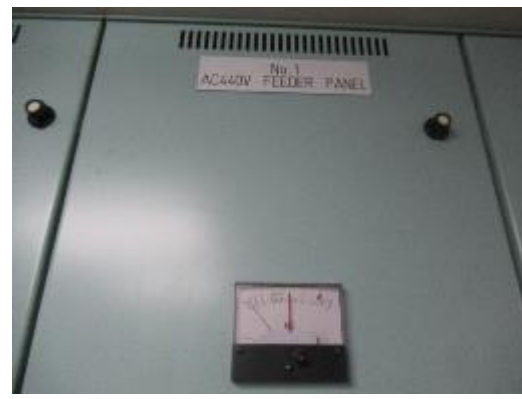
Insulation resistance of 440V.

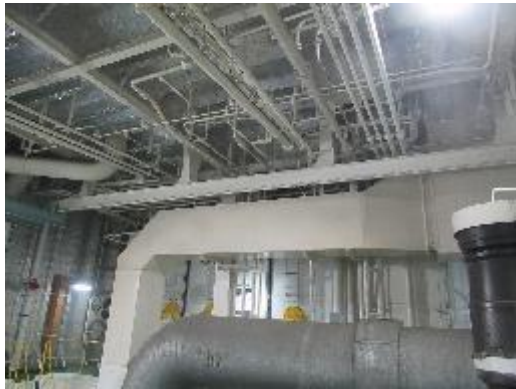
Crane gantry in engine room, SWL should be marked for all visible.

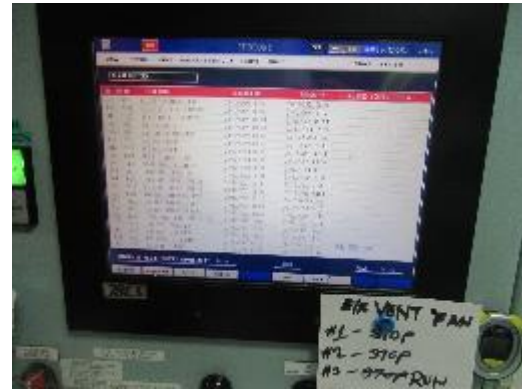
Bilge alarm test records

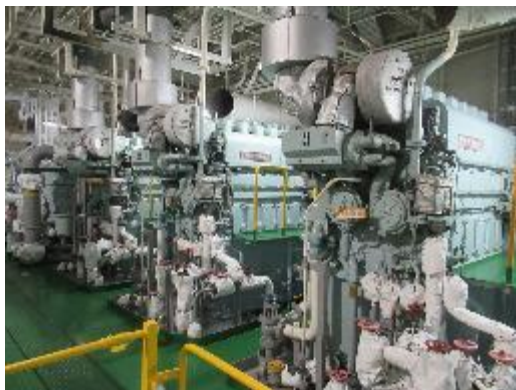
General views for Generator side (3 sets)

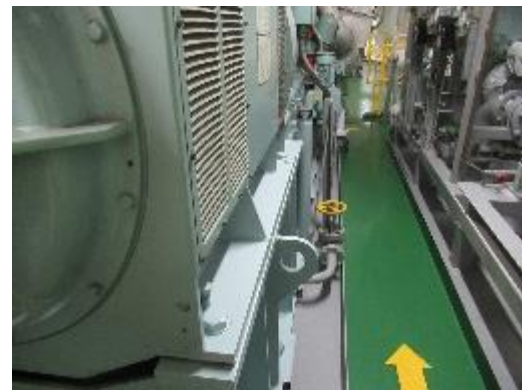
### Cleaning condition for Generators

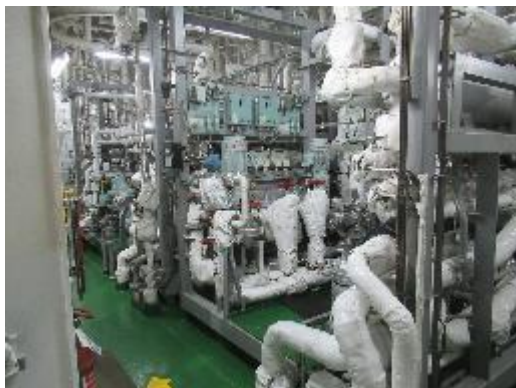
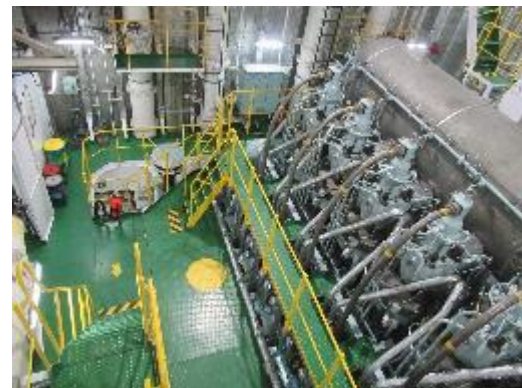
Arrangement of E/R

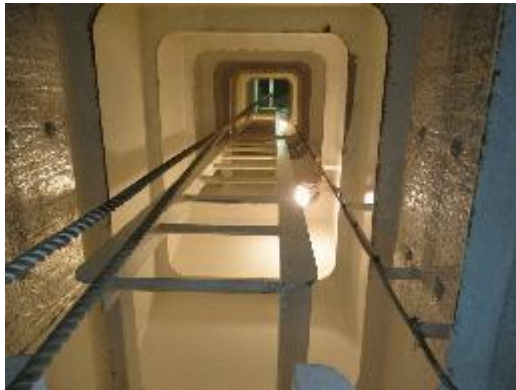
Walkway and arrangement of E/R

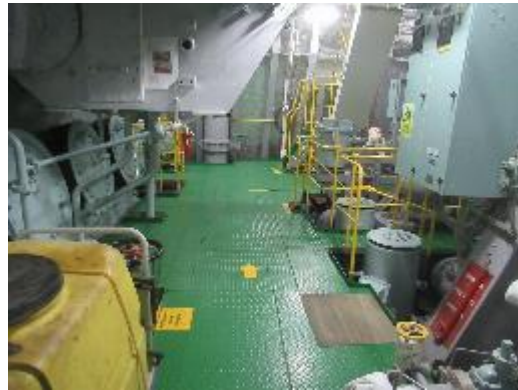
Escape route

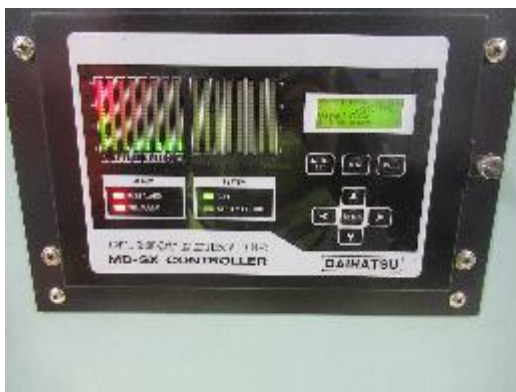
Escape indicator

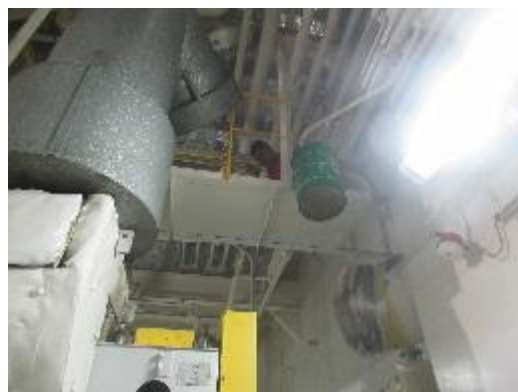
Randomly test for oil mist alarm, ok

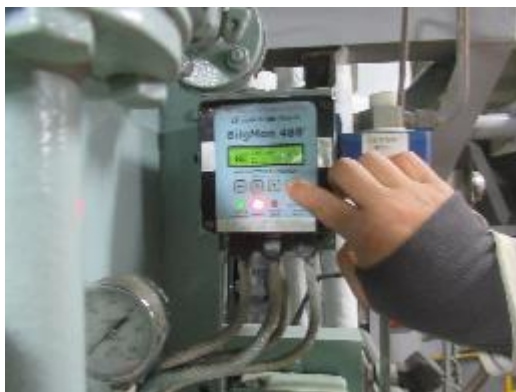
Hype mist system test above incinerator , ok

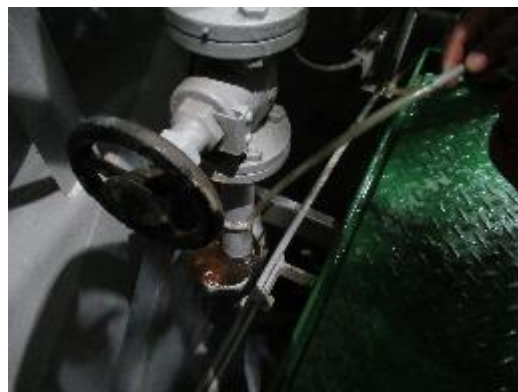
15ppm alarm test, result ok

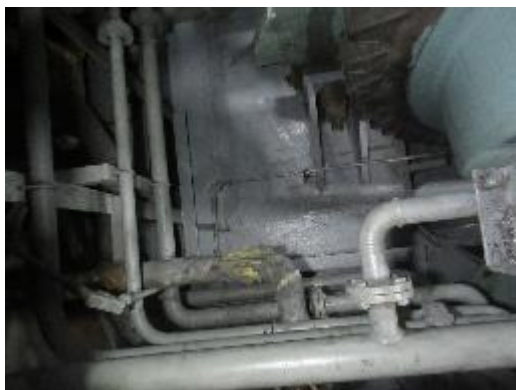
OWS test from tank to tank, result ok

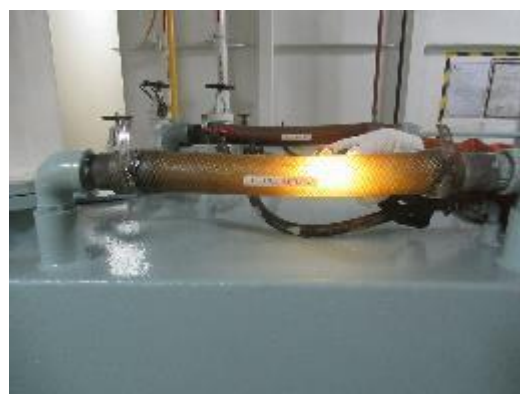
Flame fault test for incinerator

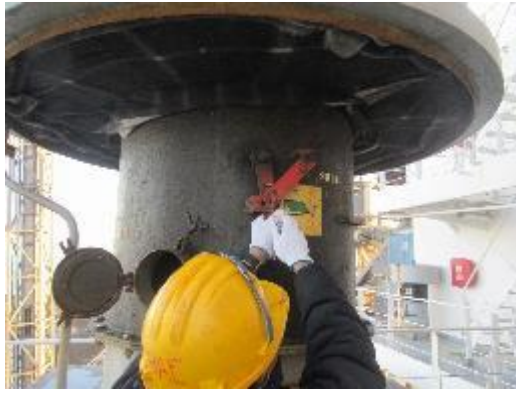
Function test for engine vent was conducted.

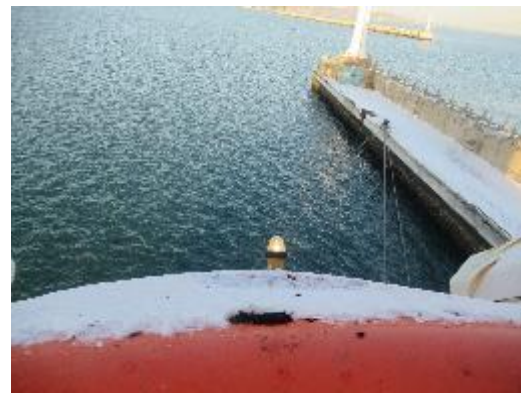
Test boat engine and steering system, lighting system, result in ok

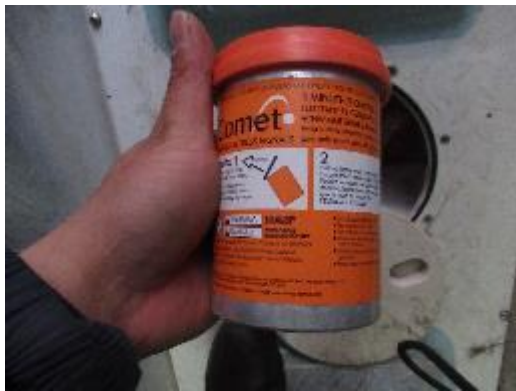
Checked inventory in lifeboat

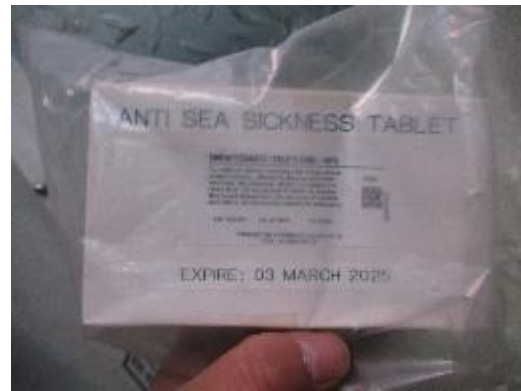
Checked inventory in lifeboat

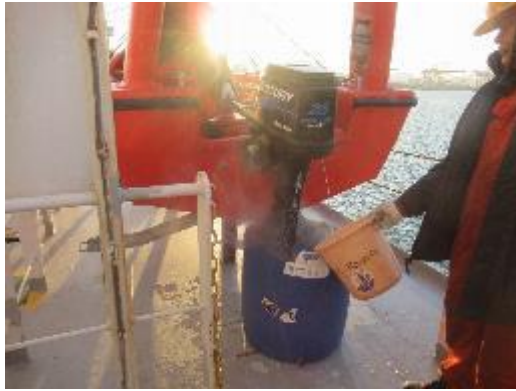
Functional test for rescue boat engine is ok

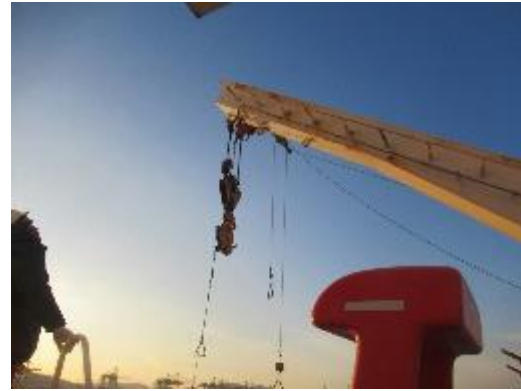
Switch limit functional test, result is ok

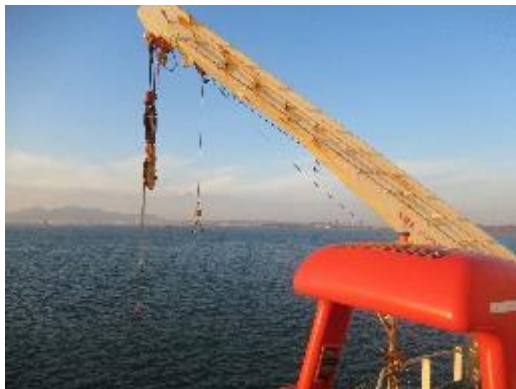
Life raft/rescue boat davits test is ok

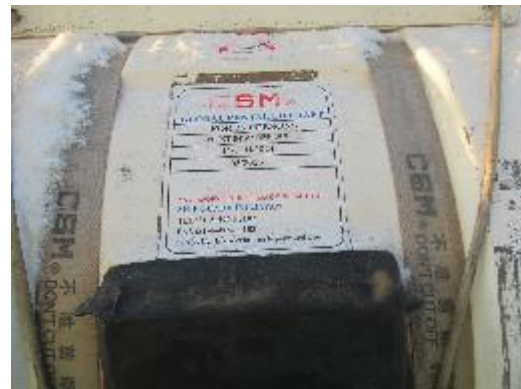
Life raft inspection

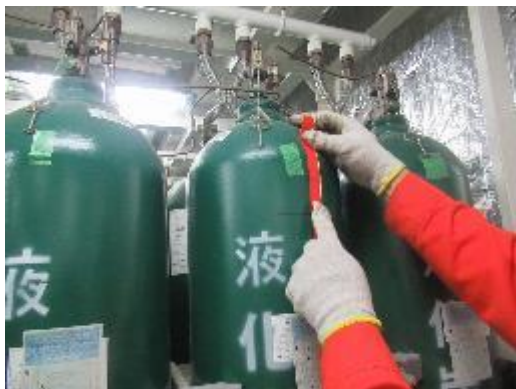
CO2 room inspected

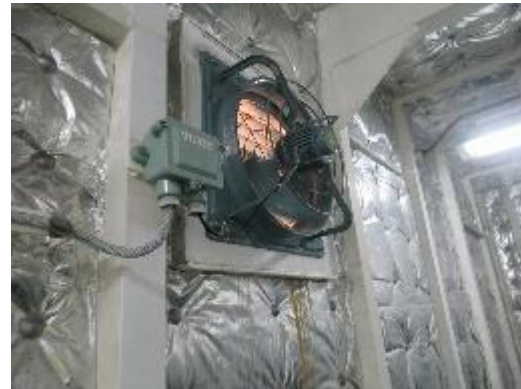
Mechanical ventilator in CO2 room operative

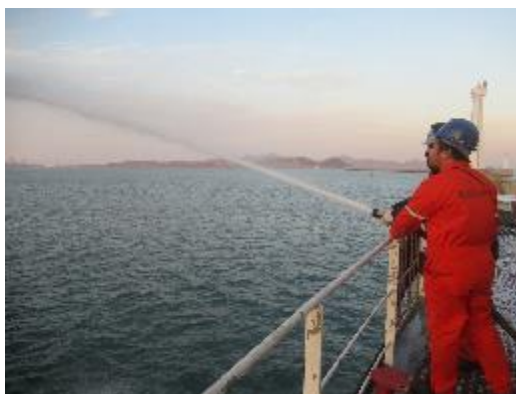
Emergency fire pump test

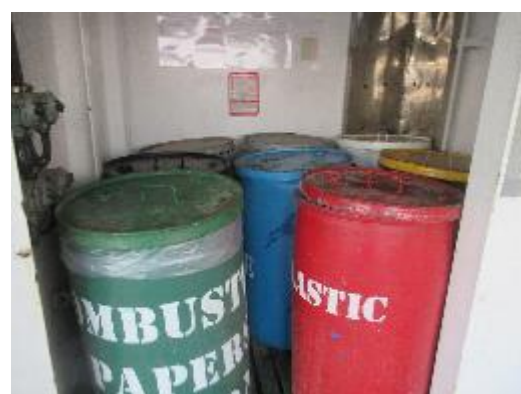
Garbage collect drum with post was observed

in good

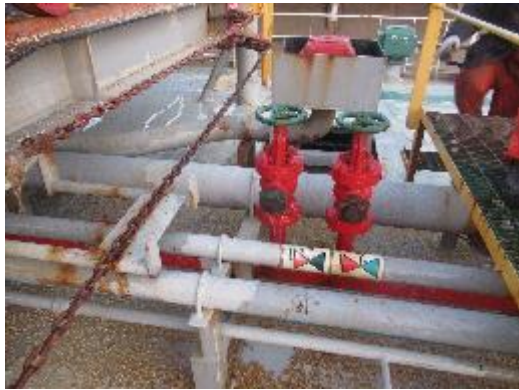
Pipe lines on deck	Drainage non return valves

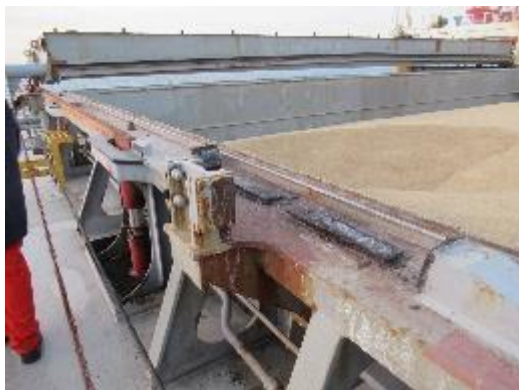
Hatch coaming condition	Hydraulic jack for hatch cover operation

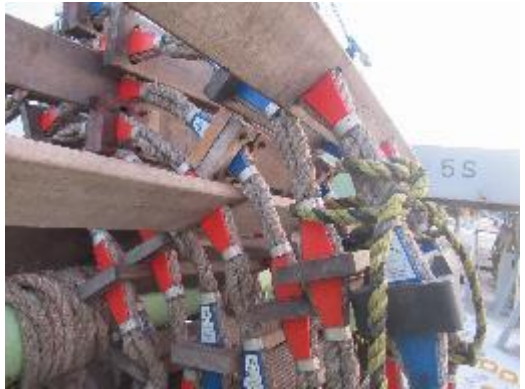
<p>Pilot ladder condition in order</p>	<p>Pilot ladder brand with ISO standard</p>

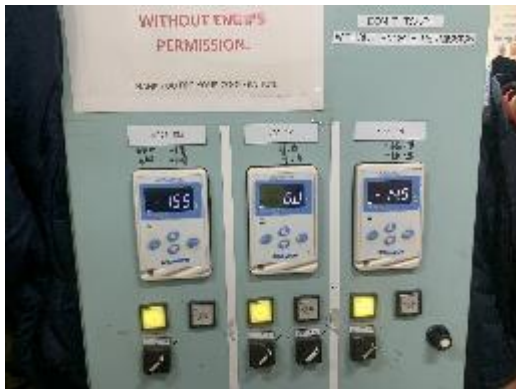
Chamber temp.

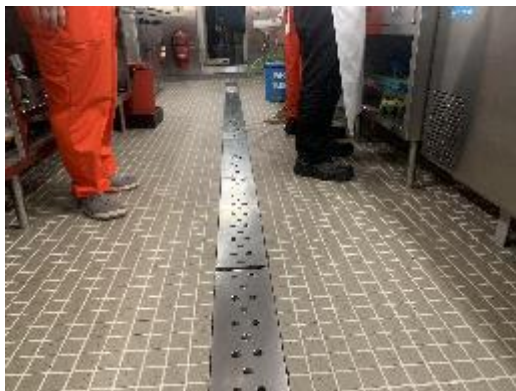
Galley floor in good condition

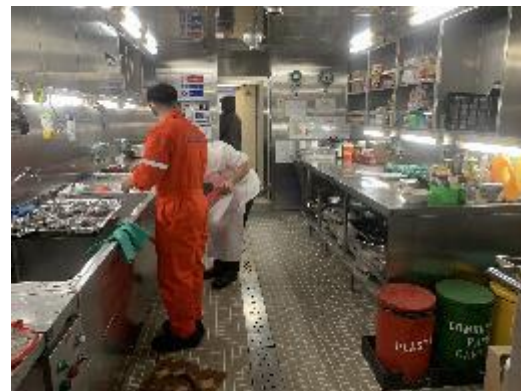
Galley condition

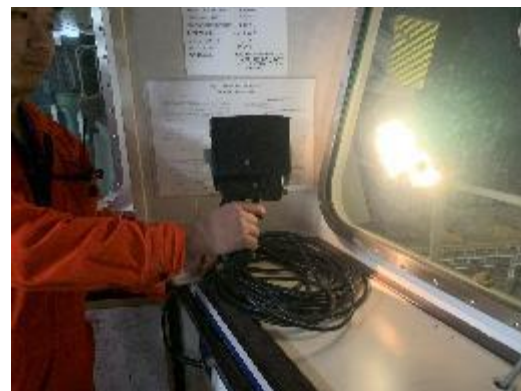
Searching light test

using of Battery mode

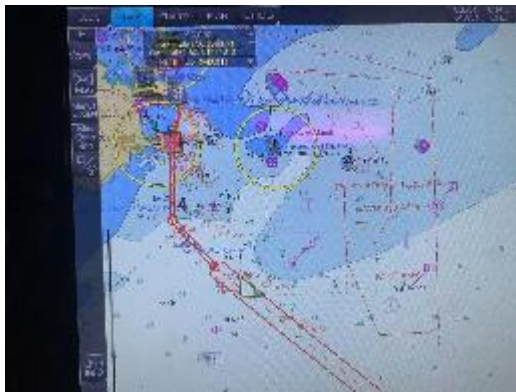
ECDIS setting inspection

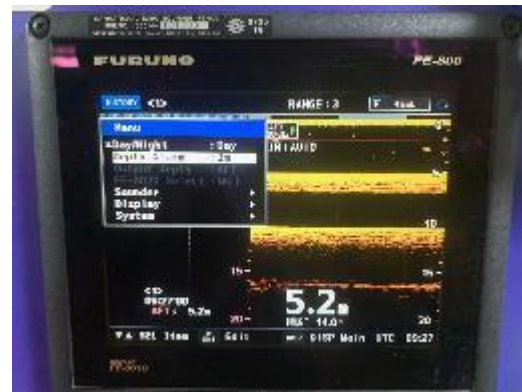
UKC setting inspection

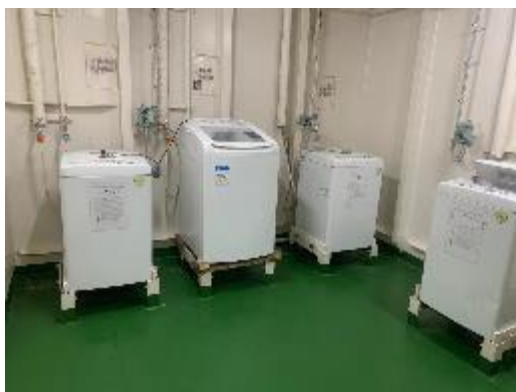
Washing machine, all operative

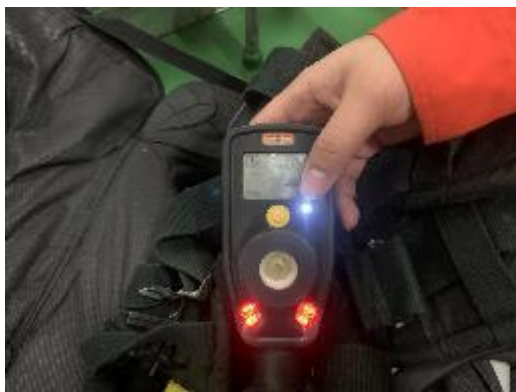
Low pressure alarm test for SCBA

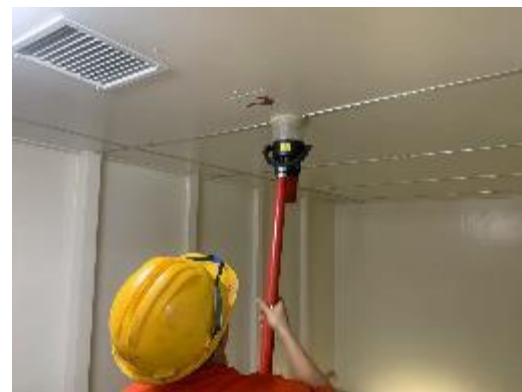
Smoke detect test for fire alarm panel.
